Checklist for P.E. Annual Inspection for CCR Surface Impoundments, § 257.83(b)

Sikeston BMU Sikeston Power Station Bottom Ash Surface Impoundment

Annual Inspection

SIKESTON POWER STATION
Bottom Ash Pond
Annual Inspection Check Sheet

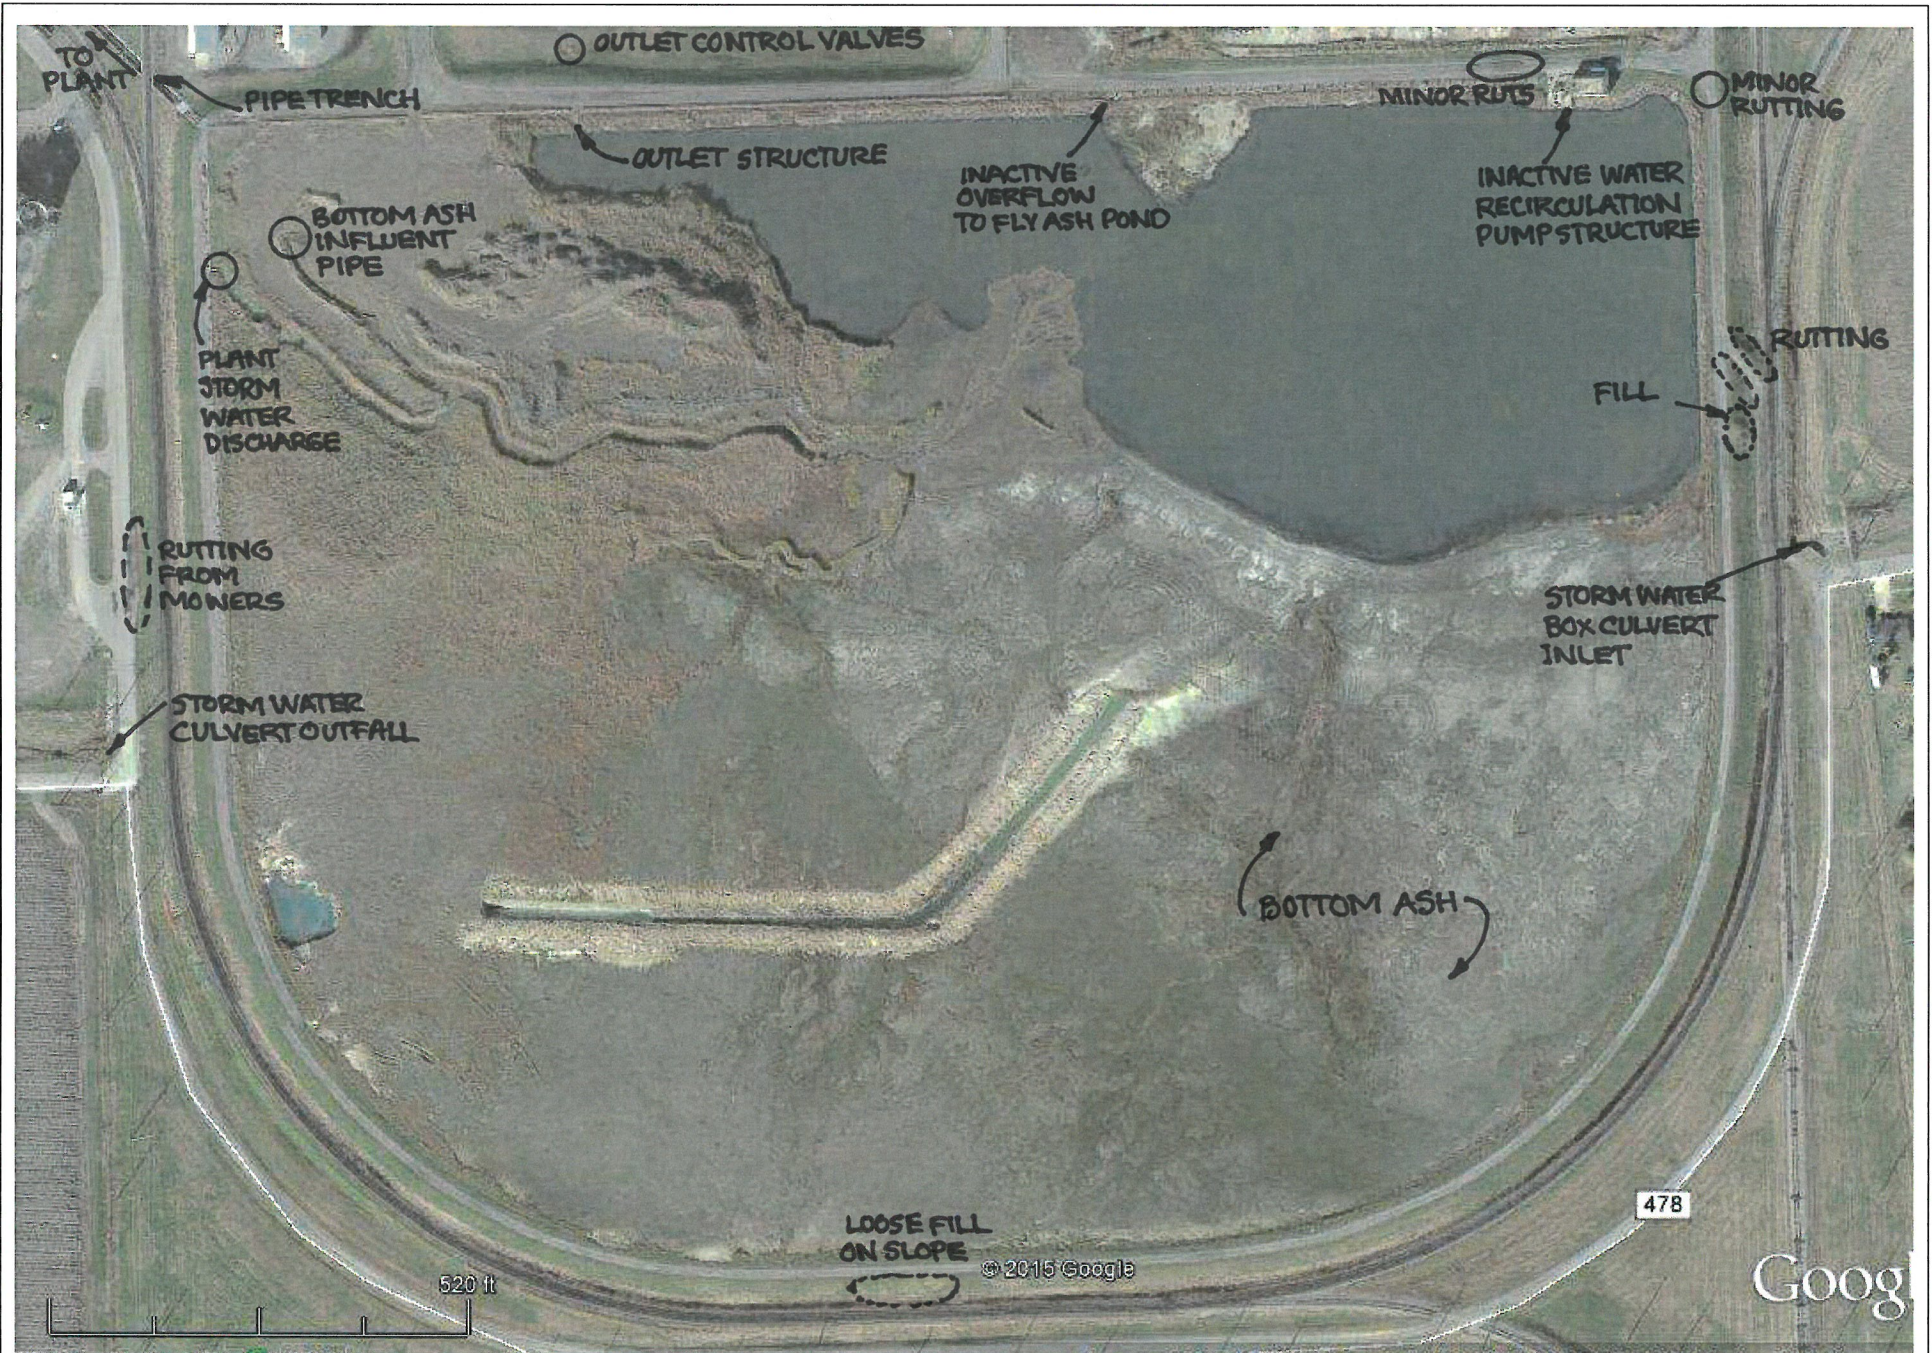
Note location of observations on attached plan sheet.

Item	Condition Code	Comments
Vertical & Horizontal Alignment of Crest	GC	No visible evidence of deformation of embankment. Some soil fill has been dumped on the exterior slope on the south side and near the NE corner. This does not affect slope stability.
Seepage/Wetness / Ponding Areas	NE (Seepage) / MM (Ponding)	Water ponds occasionally in the perimeter flat bottom ditch. This does not appear to be seepage. This is only a problem with maintenance of the ditch (i.e. mowing). An area of high grass and vegetation exists along the toe of the north embankment (see plan). Determined the high grass is because the area was too wet to mow. This is a low area of the adjacent field where runoff collects. There was no evidence of seepage or soft area along the north embankment of the Bottom Ash Pond.
Erosion/Rutting	MM	Minor rutting along west exterior slope from mowers. Minor rutting in gravel road in NE and NW corners and along NE ramp (see plan).
