**Sikeston Board of Municipal Utilities
Sikeston Power Station
Fly Ash Pond
Structural Stability Assessment**

**Sikeston Power Station
1551 West Wakefield Avenue
Sikeston, MO 63801**

April 2018

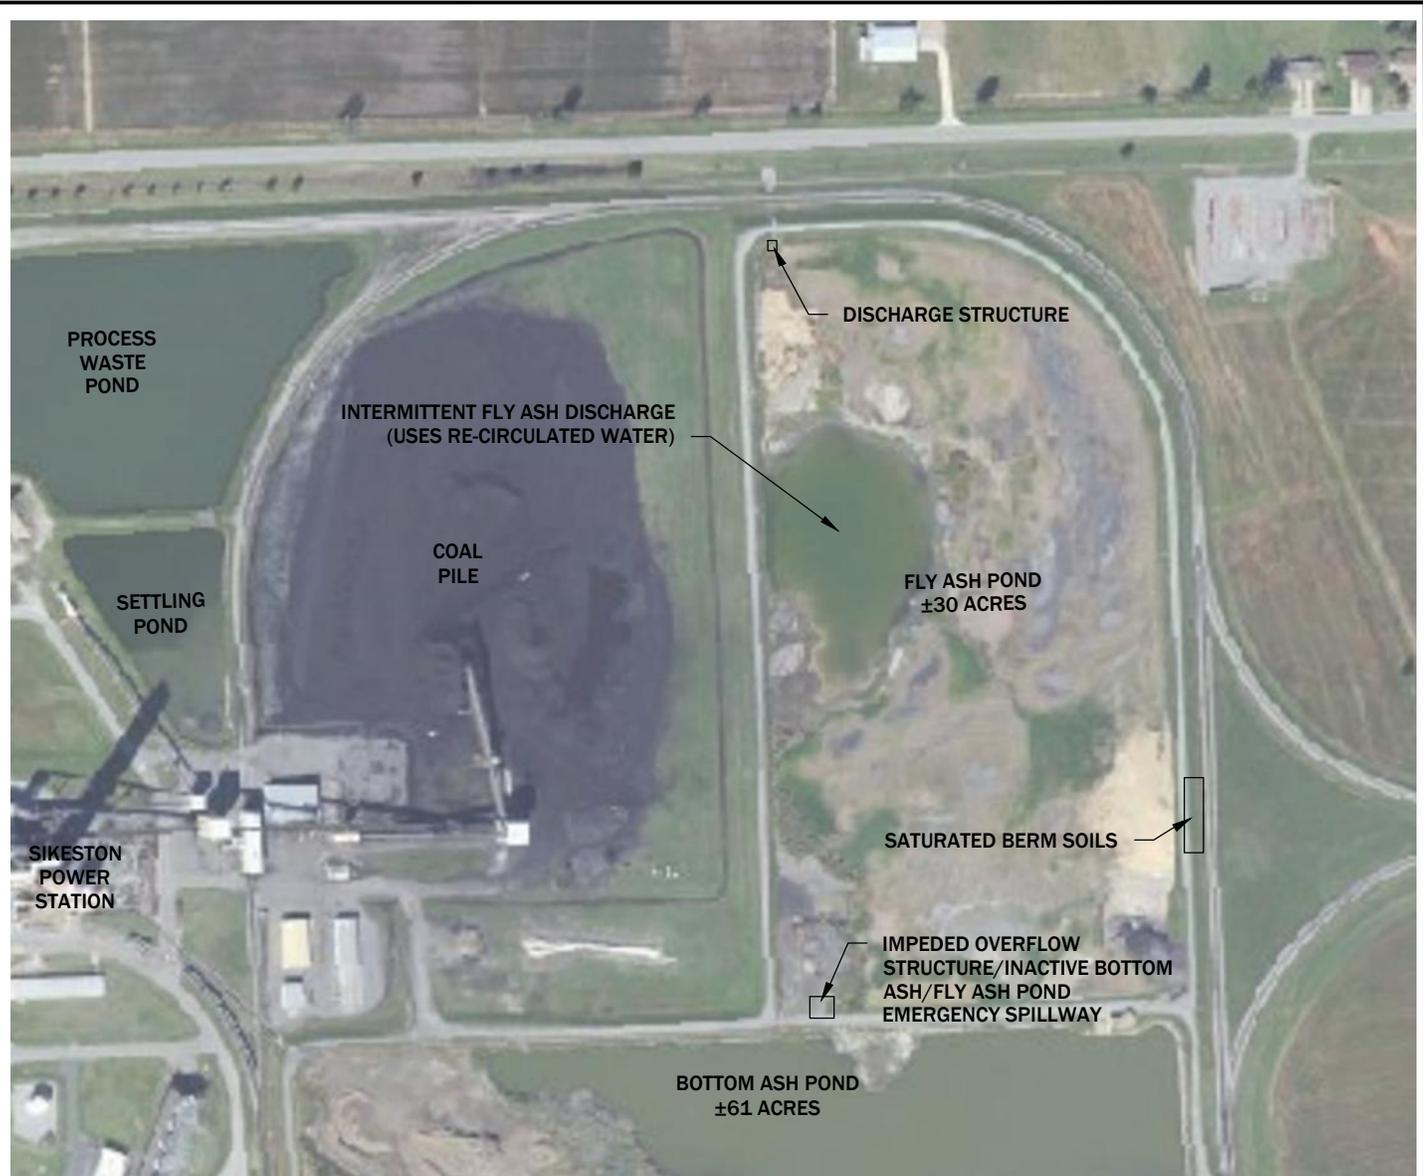
**FIGURE 2 - FLY ASH POND
IDENTIFIED DEFICIENCIES**

A visual inspection of the berms of the Fly Ash Pond identified a small area of saturated soil along the southeastern berm of the Fly Ash Pond and north of the Bottom Ash Pond. The wet ground conditions were observed to begin approximately midway on the exterior slope of the berm (approximate elevation of 314 feet) and continued to the toe of the exterior slope of the berm. The type of grass vegetation was visually observed to change along a horizontal line along the exterior slope of the berm that generally matched the beginning of the wet conditions.

The presence of hydric plants indicate that the wet condition of the soil may be the result of seepage through the southeastern berm from the Fly Ash Pond. However, no visible flow was observed and stability analysis of critical sections of Fly Ash Pond berms by Reitz & Jens, as a sub-consultant to Gredell Engineering, reportedly exceed the minimum Factors of Safety required by the CCR rule.

Based on the observations and rationale described above, the wet, saturated soil condition is identified as a deficiency under the rule. Consistent with recognized and generally accepted good engineering practices, it is recommended corrective measures be undertaken by SBMU to further

One hydraulic deficiencies were found during the assessment of the Fly Ash Pond. The emergency spillway between the Bottom Ash Pond and the Fly Ash Pond was found to be deficient due to excess fly ash at the discharge of the 30-inch corrugated metal pipe impeding the flow path between the two ponds. Consistent with recognized and generally accepted good engineering practices, it is recommended corrective measures be taken to either remove the accumulated CCR from the discharge end of the overflow structure, or construct an alternate overflow structure (i.e., emergency spillway) capable of adequately managing flow during and following the peak discharge from the design flood event.

- Outlet Structure #2: The concrete discharge structure serving the 24-inch steel and CMP pipes appeared in good condition with no visual signs of deterioration. The inlet of the 24-inch CMP pipe was behind a closed valve and therefore, not directly observed. The control valve serving the discharge was observed to be in poor condition and was reported to have not been recently operated per plant personnel.

- Emergency spillway: The 30-inch CMP between the Fly Ash Pond and Bottom Ash Pond is not used due to the adequate hydraulic capacity of the Fly Ash Pond. The emergency spillway needs maintenance to remove accumulated CCR in the event it is desired to use the structure in the future. The CMP is in good condition and serves as an interior overflow.

- A small area of wet/saturated soil was identified along the exterior of the eastern berm of the Fly Ash Pond. The wet area was observed a few feet above the toe of the exterior slope of the berm above the railroad track. The small area was manifested as a patch of hydrophilic plants (e.g., cattails). Therefore, Gredell Engineering has identified this condition as a potential CCR rule deficiency.

evaluate the potential seepage through the northern berm of the Bottom Ash Pond. The evaluation should recommend appropriate corrective measures to stabilize and/or repair the northern berm of the Bottom Ash Pond. At a minimum, corrective measures should be taken to improve the conditions for future routine maintenance (i.e., mowing) and observation.

Generally accepted good engineering practices for surface impoundments typically include secondary discharge structures or spillways in the event a surface impoundment's active spillway is deemed inoperable. Accordingly, it is recommended corrective measures be taken to remove the obstructions to the inlet end of the pipe in the inactive Fly Ash Pond to render it operative. Alternatively, design and install a broad crested weir emergency spillway in the Fly Ash Pond berm at least 100 feet west of the inoperable structure.

- Gredell Engineering recommends further investigation of the wet area along the eastern berm of the Fly Ash Pond. If the wet area is confirmed to be caused by seepage from the Fly Ash Pond, corrective measures will be necessary to remediate this condition. An evaluation should be made that recommends appropriate corrective measures to stabilize and/or repair the eastern berm of the Fly Ash Pond.

- Gredell Engineering recommends repair of Outlet Structure #2 valves. The valves should be operable for future large rainfall events.

recommended that measures be taken to either: 1) render the existing secondary overflow structure operable (this would involve removing the obstructions to the discharge end of the pipe in the inactive Fly Ash Pond); or 2) to construct an alternative, secondary overflow structure (an alternate, secondary overflow structure could be the installation of a broad crested weir spillway in the Fly Ash Pond berm at least 100 feet south of northwest outlet structure).
