**Sikeston Board of Municipal Utilities
Sikeston Power Station
Bottom Ash Pond
Structural Stability Assessment**

**Sikeston Power Station
1551 West Wakefield Avenue
Sikeston, MO 63801**

October 17, 2016

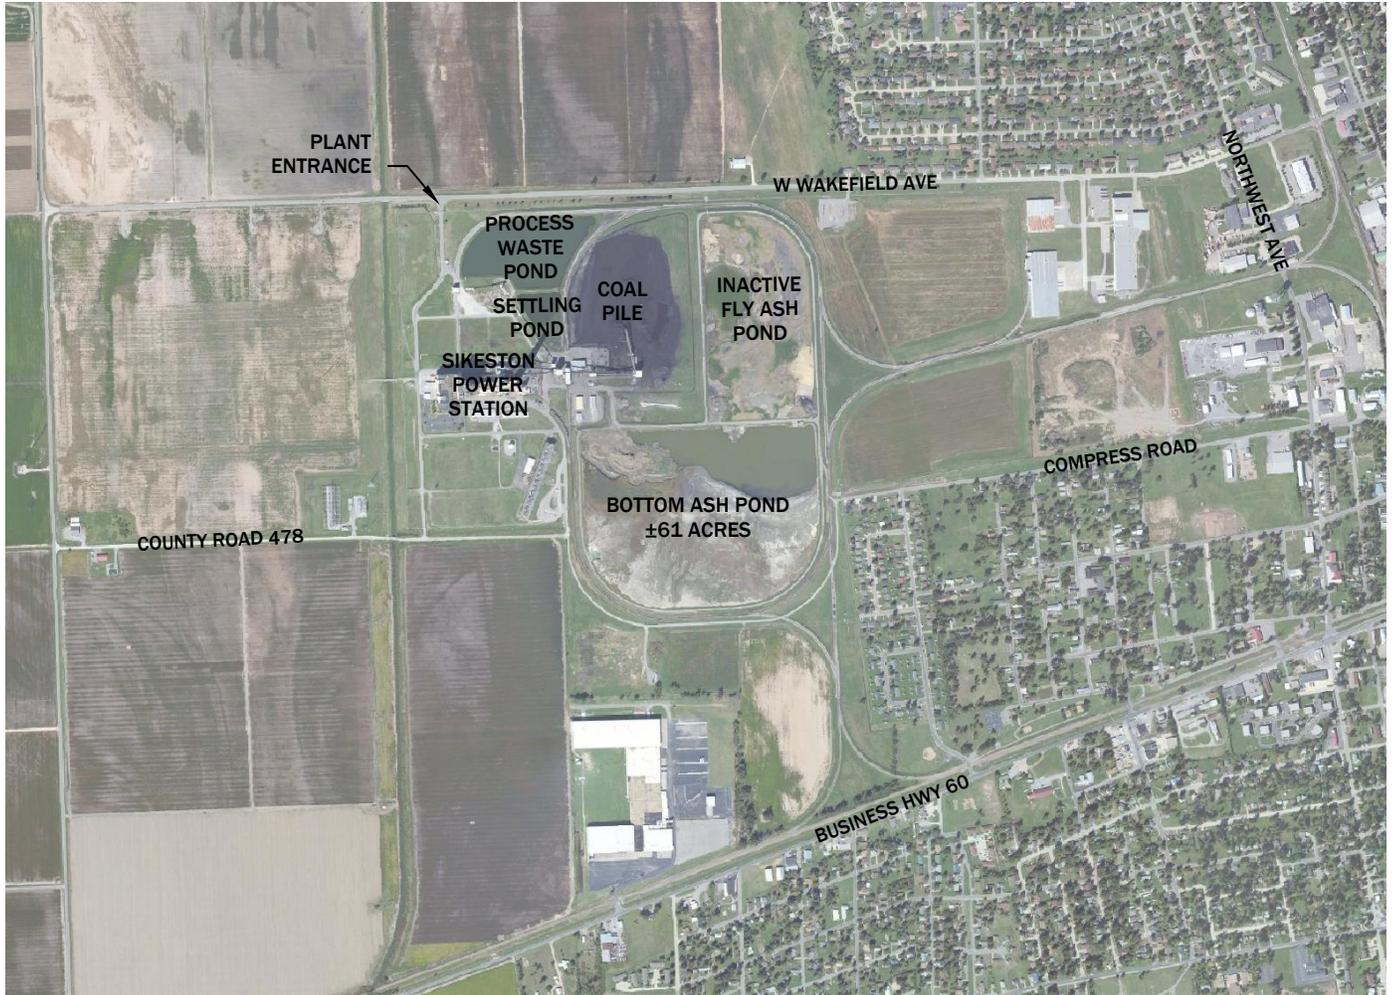
FIGURE 1 - AERIAL VIEW

SPS and the Bottom Ash Pond are located at a transition between agricultural and urban areas. The Bottom Ash Pond is surrounded by agricultural, commercial, and residential areas. Residential areas are located approximately 150 feet east/southeast of the Bottom Ash Pond. Commercial areas are located approximately 700 feet south of the Bottom Ash Pond. The remaining area around the Bottom Ash Pond is agricultural land. There is City-owned property to the east, south, and west of the Bottom Ash Pond. See Appendix A, Figure 1 – Aerial View, for a depiction of the Bottom Ash Pond.

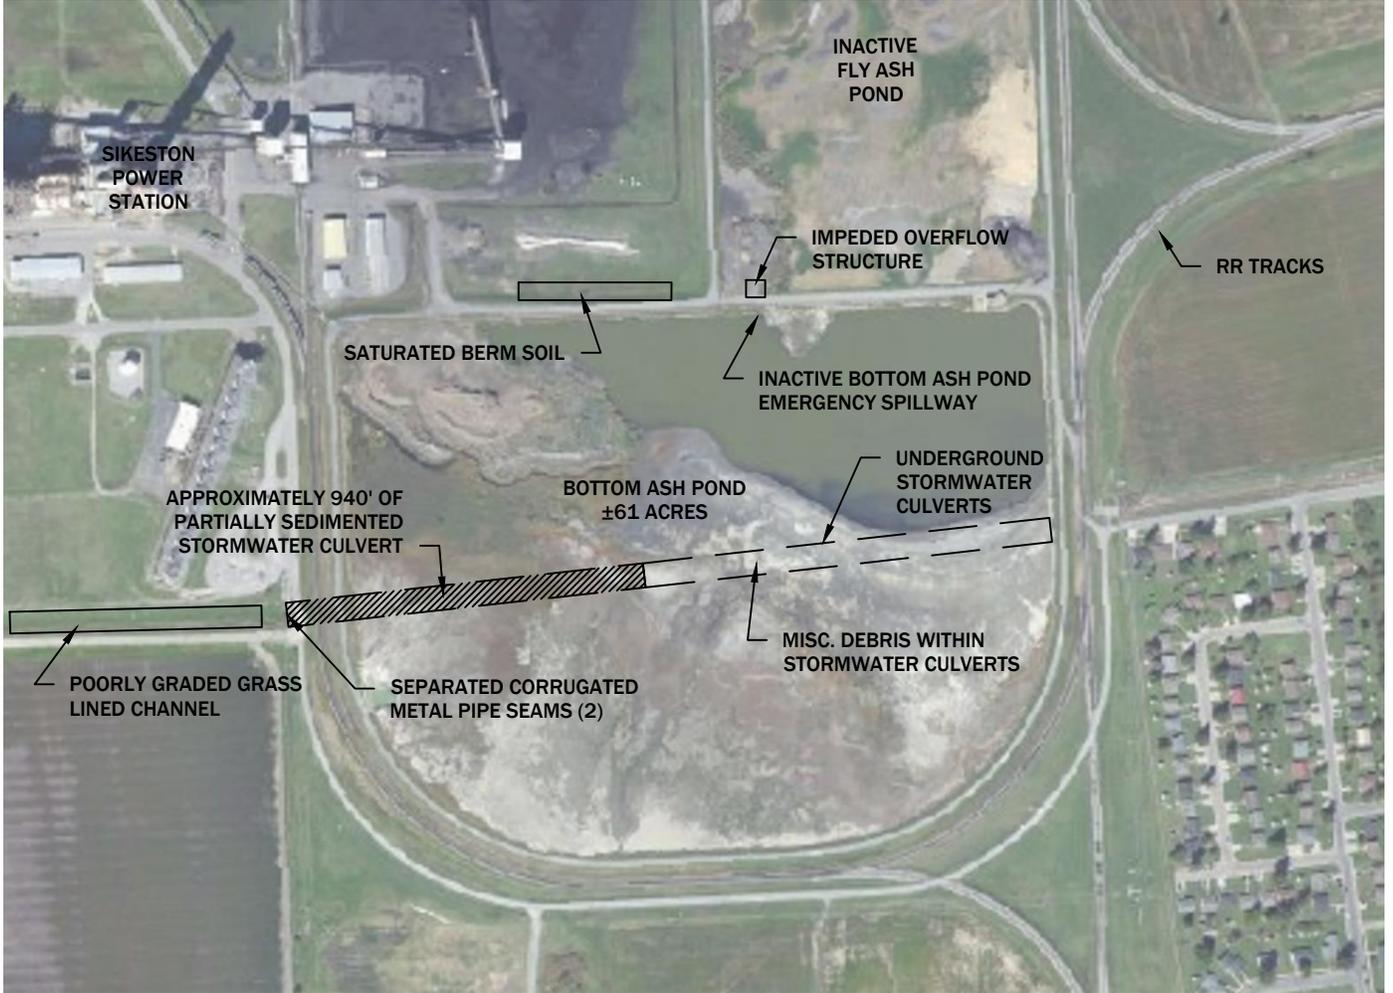
**FIGURE 2 - BOTTOM ASH POND
IDENTIFIED DEFICIENCIES**

- An area of wet/saturated soil was identified along the exterior of the northern berm of the Bottom Ash Pond and west of the Fly Ash Pond. The wet area was observed from the toe of the exterior slope up the berm to an approximate elevation of 314 feet. Due to a lack of recent precipitation and other observations made in the field, the wet/saturated condition of the soil may be an indication of seepage from the Bottom Ash Pond through this portion of north berm. Therefore, Gredell Engineering has identified this condition as a CCR rule deficiency.

- The bottom elevation of the grass lined channel downstream of the discharge of the stormwater culverts underneath the Bottom Ash Pond was observed to be higher than the invert discharge elevation of the stormwater culverts. The elevation of the grass lined channel reduces the velocity of water discharging from the stormwater culverts, resulting in sedimentation within the culverts. The elevation of the bottom of the grass lined channel negatively impacts the operation of the stormwater culverts by reducing the discharge total flow and velocity of stormwater from the culverts. Therefore, the elevation of the bottom of the grass lined channel is identified as a CCR rule deficiency.

- The build-up of sediment and debris observed within the concrete and corrugated metal pipe sections of the stormwater culverts underneath the Bottom Ash Pond creates a

negative impact on the operation of the hydraulic structures by reducing the hydraulic capacity and velocity within the stormwater culverts. The sediment within the metal pipe section of the stormwater culverts reduces the hydraulic capacity and flow velocity within the stormwater culverts. However, the percentage reduction of the total cross sectional area of the stormwater culverts is 25% or less. It is noted that the flat topography surrounding the Bottom Ash Pond will likely result in all surrounding onsite and offsite stormwater conveyances being full during a significant flood event. As such, the reduced capacity of the stormwater culverts is not expected to result in the upstream inundation of the Bottom Ash Pond due to the reduced capacity of the structure. Nevertheless, Gredell Engineering has identified the build-up of sediment and debris in the stormwater culverts as a CCR rule deficiency.

- The southern stormwater culvert appears to be in good condition except for two locations where seams near the top of the corrugated metal pipe have been damaged and separated. The bituminous lining of both the corrugated metal culverts is cracking and deteriorating and could no longer function properly. Therefore, the separated seams of the southern stormwater culvert are identified as a CCR rule deficiency.

Gredell Engineering recommends further investigation of the wet area along the northern berm of the Bottom Ash Pond. If the wet area is confirmed to be caused by seepage from the Bottom Ash Pond, corrective measures will be necessary to remediate this condition. An evaluation should be made that recommends appropriate corrective measures to stabilize and/or repair the northern berm of the Bottom Ash Pond. At a minimum, corrective measures should be taken to improve the conditions of the berm for future routine maintenance (i.e., mowing) and observation.

The recommended corrective measure is to lower the elevation of the bottom of the grass lined channel by at least 1-foot below the elevation of the stormwater culverts for a minimum of 100 feet downstream of the discharge end of the culverts. This will allow complete discharge of the stormwater culverts following a rainfall event. The excavation of the channel will also provide a sediment trap for the deposition of future sediments in the stormwater flow.

Gredell Engineering recommends corrective measures be taken to remove the sediment and debris (individual rip-rap stones and tires) from within both stormwater culverts located beneath the Bottom Ash Pond.

Gredell Engineering recommends repair of the separated seams of the corrugated metal pipe section in the southern stormwater culvert.

Although not identified as a CCR rule deficiency, generally accepted engineering practices for surface impoundments typically include secondary discharge structures or spillways to be used in cases of excessive flow or in the event a surface impoundment's active spillway is rendered inoperable. Currently, the Bottom Ash Pond has one, operable discharge structure. The overflow structure between the Bottom Ash Pond and the Fly Ash Pond is currently inoperable due to excess CCR accumulation at the discharge of the 30-inch corrugated metal pipe, impeding the flow of water from the Bottom Ash Pond. The inoperable overflow structure was not determined to be a deficiency because Gredell Engineering's hydrologic and hydraulic evaluation determined that the one discharge structure adequately manages the anticipated flow during, and following, the peak discharge from the design flood event (the 1,000-year flood). However, consistent with generally accepted engineering practices, it is recommended that measures be taken to either: 1) render the existing secondary overflow structure operable (this would involve removing the obstructions to the discharge end of the pipe in the inactive Fly Ash Pond); or 2) to construct an alternative, secondary overflow structure (an alternate, secondary overflow structure could be the installation of a broad crested weir spillway in the Bottom Ash Pond berm at least 100 feet west of the inoperable structure).
