Checklist for P.E. Annual Inspection for CCR Surface Impoundments, § 257.83(b)

#### Sikeston BMU Sikeston Power Station Bottom Ash Surface Impoundment

##### Annual Inspection

**SIKESTON POWER STATION – BOTTOM ASH POND  
2017 ANNUAL INSPECTION CHECK SHEET**

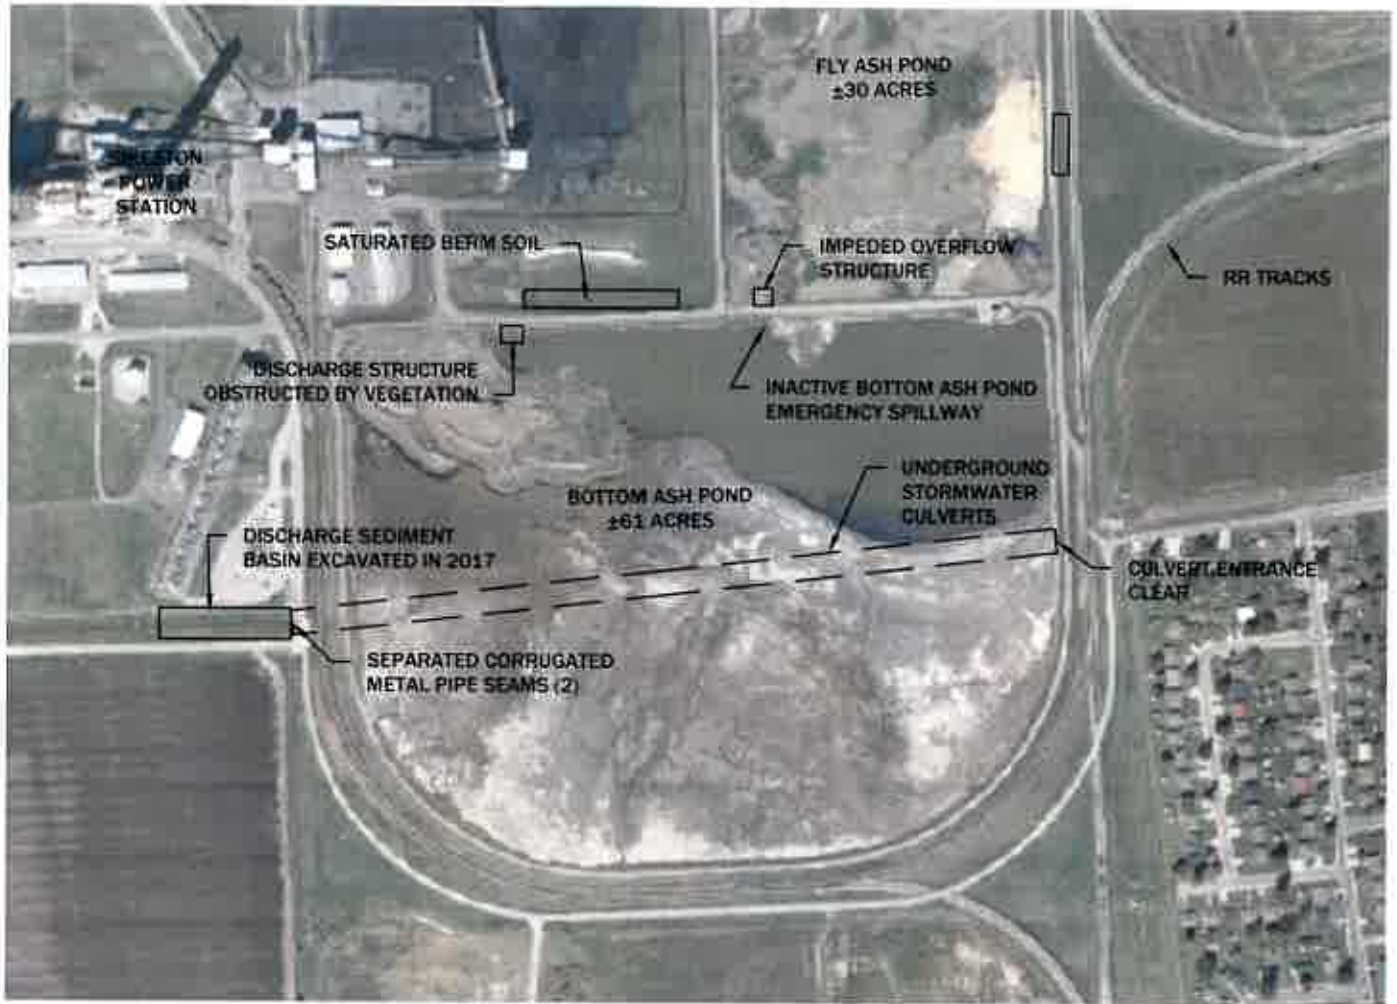
**FIGURE 1**

- a. SATURATED BERM SOIL ALONG NORTHERN BERM, WEST OF THE INACTIVE FLY ASH POND. (SAME AS 2016)
  - b. SEPARATED CORRUGATED METAL PIPE SEAMS AT THE DISCHARGE OF THE SOUTHERN STORMWATER CULVERT PASSING BENEATH THE BOTTOM ASH POND. (SAME AS 2016. REPORTED NOT REPAIRED)

- c. GRASS LINED CHANNEL AT THE DISCHARGE OF THE STORMWATER AT THE OUTLET OF THE STORMWATER CULVERTS PASSING BENEATH THE BOTTOM ASH POND FROM EAST TO WEST HAS BEEN CLEARED OF BRUSH AND EXCAVATED TO CREATE A SEDIMENT BASIN. BASIN PARTIALLY FILLED WITH SEDIMENT AND DEBRIS (2 TIRES). RE-EXCAVATED AS NEEDED.

3. ITEMS IDENTIFIED DURING THE ANNUAL INSPECTION WHICH DO NOT REQUIRE MAINTENANCE INCLUDE:
  - a. THE IMPEDED OVERFLOW STRUCTURE BETWEEN THE BOTTOM ASH POND AND THE INACTIVE FLY ASH POND.

1. MINOR MAINTENANCE ITEMS INCLUDE CLEARING VEGETATION FROM SURFACE IMPOUNDMENT DISCHARGE.
2. ITEMS REQUIRING FURTHER OBSERVATION, INVESTIGATION OR CORRECTIVE ACTION INCLUDE:
