Checklist for P.E. Annual Inspection for CCR Surface Impoundments, § 257.83(b)

Sikeston BMU Sikeston Power Station Bottom Ash Surface Impoundment

Annual Inspection

**2018 ANNUAL P.E. INSPECTION
BOTTOM ASH POND
SIKESTON POWER STATION**

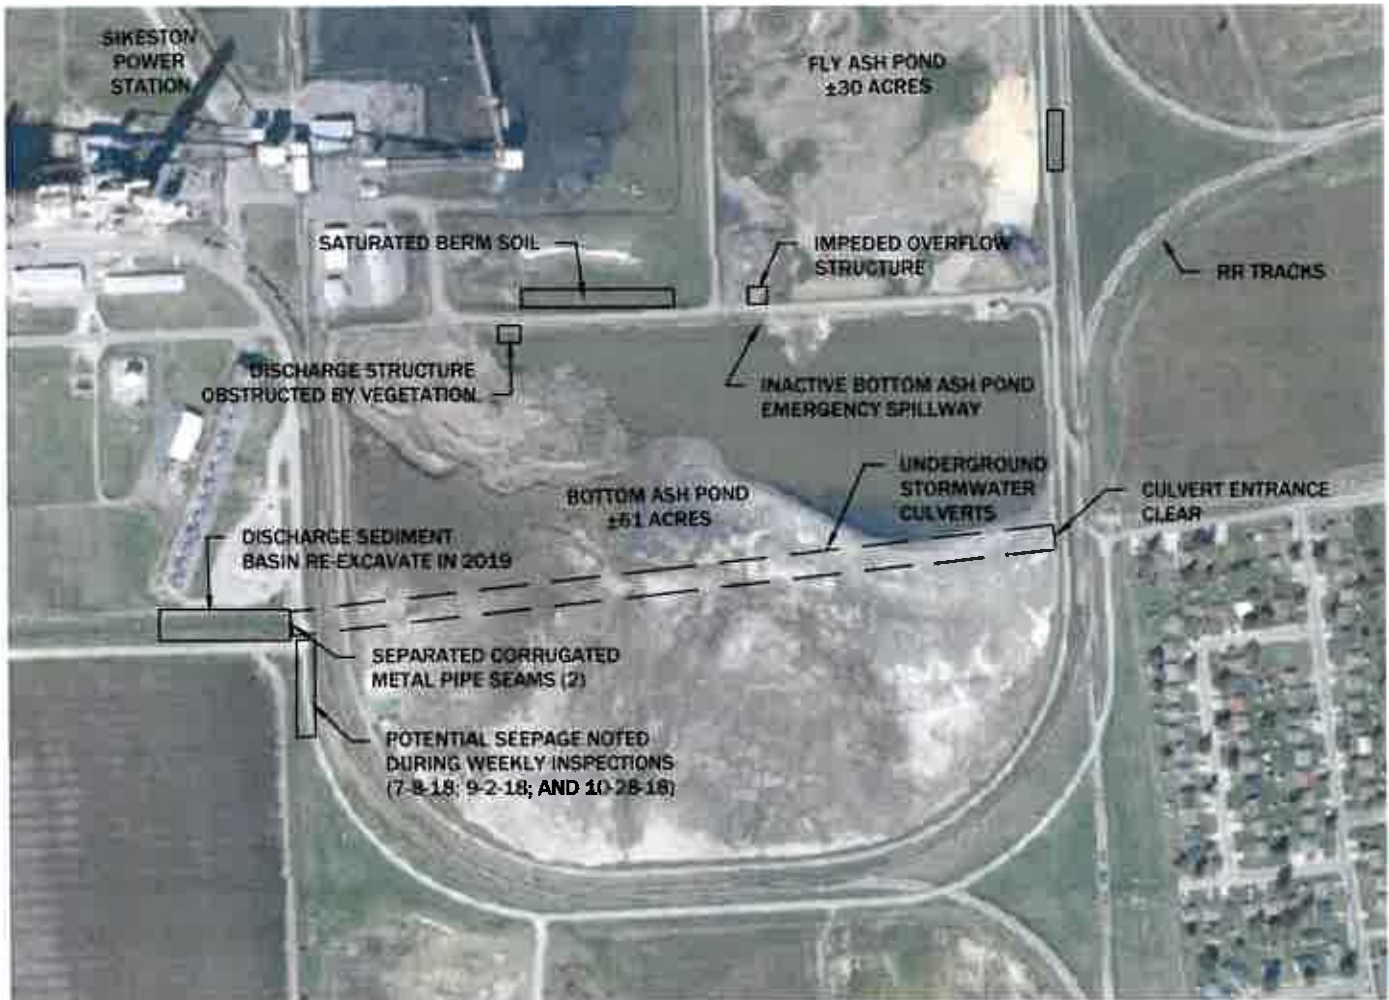
FIGURE 1

- a. SATURATED BERM SOIL ALONG NORTHERN BERM, WEST OF THE INACTIVE FLY ASH POND. (SAME AS 2017)
 - b. SEPARATED CORRUGATED METAL PIPE SEAMS AT THE DISCHARGE OF THE SOUTHERN STORMWATER CULVERT PASSING BENEATH THE BOTTOM ASH POND. (SAME AS 2017. REPORTED NOT REPAIRED)

- c. GRASS LINED CHANNEL AT THE DISCHARGE OF THE STORMWATER AT THE OUTLET OF THE STORMWATER CULVERTS PASSING BENEATH THE BOTTOM ASH POND FROM EAST TO WEST HAS BEEN CLEARED OF BRUSH AND EXCAVATED TO CREATE A SEDIMENT BASIN. BASIN FILLED WITH SEDIMENT AND DEBRIS. RE-EXCAVATE IN 2019.

3. ITEMS IDENTIFIED DURING THE ANNUAL INSPECTION WHICH DO NOT REQUIRE MAINTENANCE INCLUDE:
 - a. THE IMPEDED OVERFLOW STRUCTURE BETWEEN THE BOTTOM ASH POND AND THE INACTIVE FLY ASH POND.

1. MINOR MAINTENANCE ITEMS INCLUDE CLEARING VEGETATION FROM SURFACE IMPOUNDMENT DISCHARGE.
2. ITEMS REQUIRING FURTHER OBSERVATION, INVESTIGATION OR CORRECTIVE ACTION INCLUDE:
