Checklist for P.E. Annual Inspection for CCR Surface Impoundments, § 257.83(b)

Sikeston BMU Sikeston Power Station Bottom Ash Surface Impoundment

Annual Inspection

**2019 ANNUAL P.E. INSPECTION
BOTTOM ASH POND
SIKESTON POWER STATION**

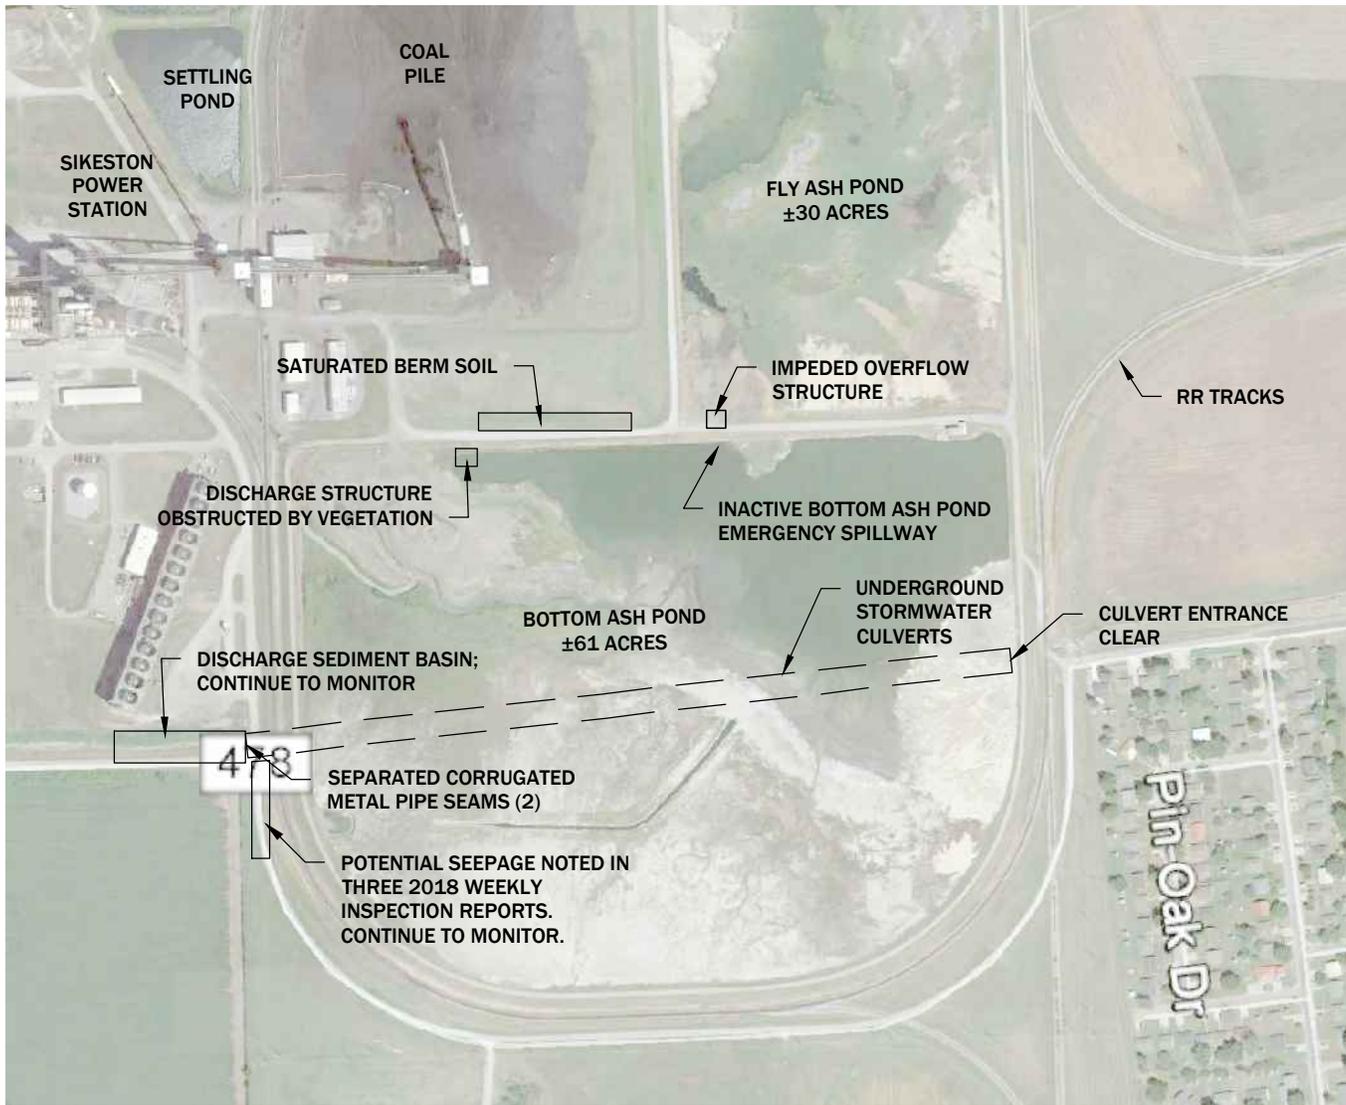
FIGURE 1

- a. SATURATED BERM SOIL ALONG NORTHERN BERM, WEST OF THE FLY ASH POND. (SAME AS 2018)
 - b. SEPARATED CORRUGATED METAL PIPE SEAMS AT THE DISCHARGE OF THE SOUTHERN STORMWATER CULVERT PASSING BENEATH THE BOTTOM ASH POND. (SAME AS 2018. REPORTED NOT REPAIRED)

- c. GRASS LINED CHANNEL AT THE DISCHARGE OF THE STORMWATER AT THE OUTLET OF THE STORMWATER CULVERTS PASSING BENEATH THE BOTTOM ASH POND FROM EAST TO WEST HAS BEEN CLEARED OF BRUSH AND EXCAVATED TO CREATE A SEDIMENT BASIN. BASIN PARTIALLY FILLED WITH SEDIMENT AND DEBRIS. RE-EXCAVATE AS NEEDED.

3. ITEMS IDENTIFIED DURING THE ANNUAL INSPECTION WHICH DO NOT REQUIRE MAINTENANCE INCLUDE:
 - a. THE IMPEDED OVERFLOW STRUCTURE BETWEEN THE BOTTOM ASH POND AND THE FLY ASH POND.

1. MINOR MAINTENANCE ITEMS INCLUDE CLEARING VEGETATION FROM SURFACE IMPOUNDMENT DISCHARGE.
2. ITEMS REQUIRING FURTHER OBSERVATION, INVESTIGATION OR CORRECTIVE ACTION INCLUDE:
