Checklist for P.E. Annual Inspection for CCR Surface Impoundments, § 257.83(b)

Sikeston BMU Sikeston Power Station Fly Ash Surface Impoundment

Annual Inspection

SIKESTON POWER STATION – FLY ASH POND
2019 ANNUAL INSPECTION CHECK SHEET

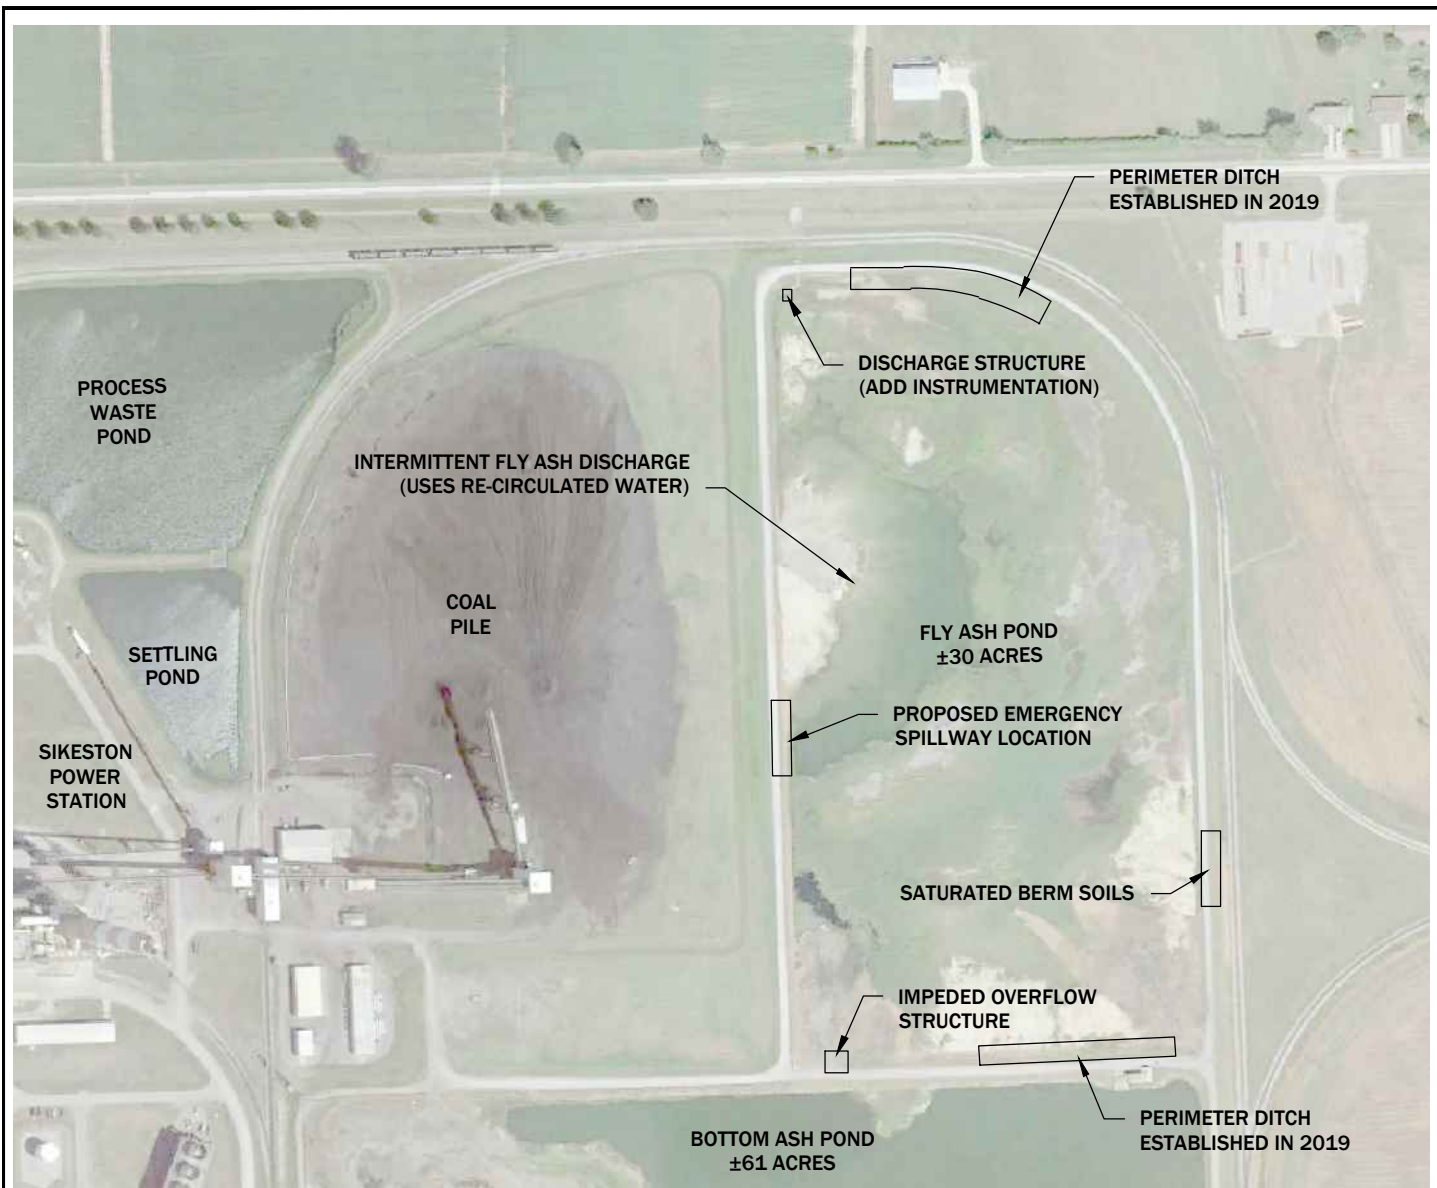
FIGURE 1

1. The location of observations on attached plan sheet (Figure 1).

2. REQUIRING FURTHER OBSERVATION INCLUDE:
 - a. SATURATED BERM SOIL ALONG SOUTHEAST BERM.

3. ITEMS IDENTIFIED DURING THE INITIAL INSPECTION WHICH DO NOT REQUIRE MAINTENANCE INCLUDE:
 - a. THE IMPEDED OVERFLOW STRUCTURE BETWEEN THE BOTTOM ASH POND AND THE FLY ASH POND.

1. MINOR MAINTENANCE ITEMS INCLUDE:
 - a. CLEAN SEDIMENT AND VEGETATION FROM DISCHARGE STRUCTURE.
 - b. ADD INSTRUMENTATION (STAFF GAUGE).
 - c. REPAIR INOPERABLE GATE VALVE TO THE PROCESS WATER POND OR DEVELOP AN EMERGENCY SPILLWAY.
 - d. EXCAVATE STORMWATER CHANNEL 2 FEET DEEP ALONG POND PERIMETER (WHERE REQUIRED)
