Checklist for P.E. Annual Inspection for CCR Surface Impoundments, § 257.83(b)

Sikeston BMU Sikeston Power Station Bottom Ash Surface Impoundment

Annual Inspection

**2020 ANNUAL P.E. INSPECTION
BOTTOM ASH POND
SIKESTON POWER STATION**

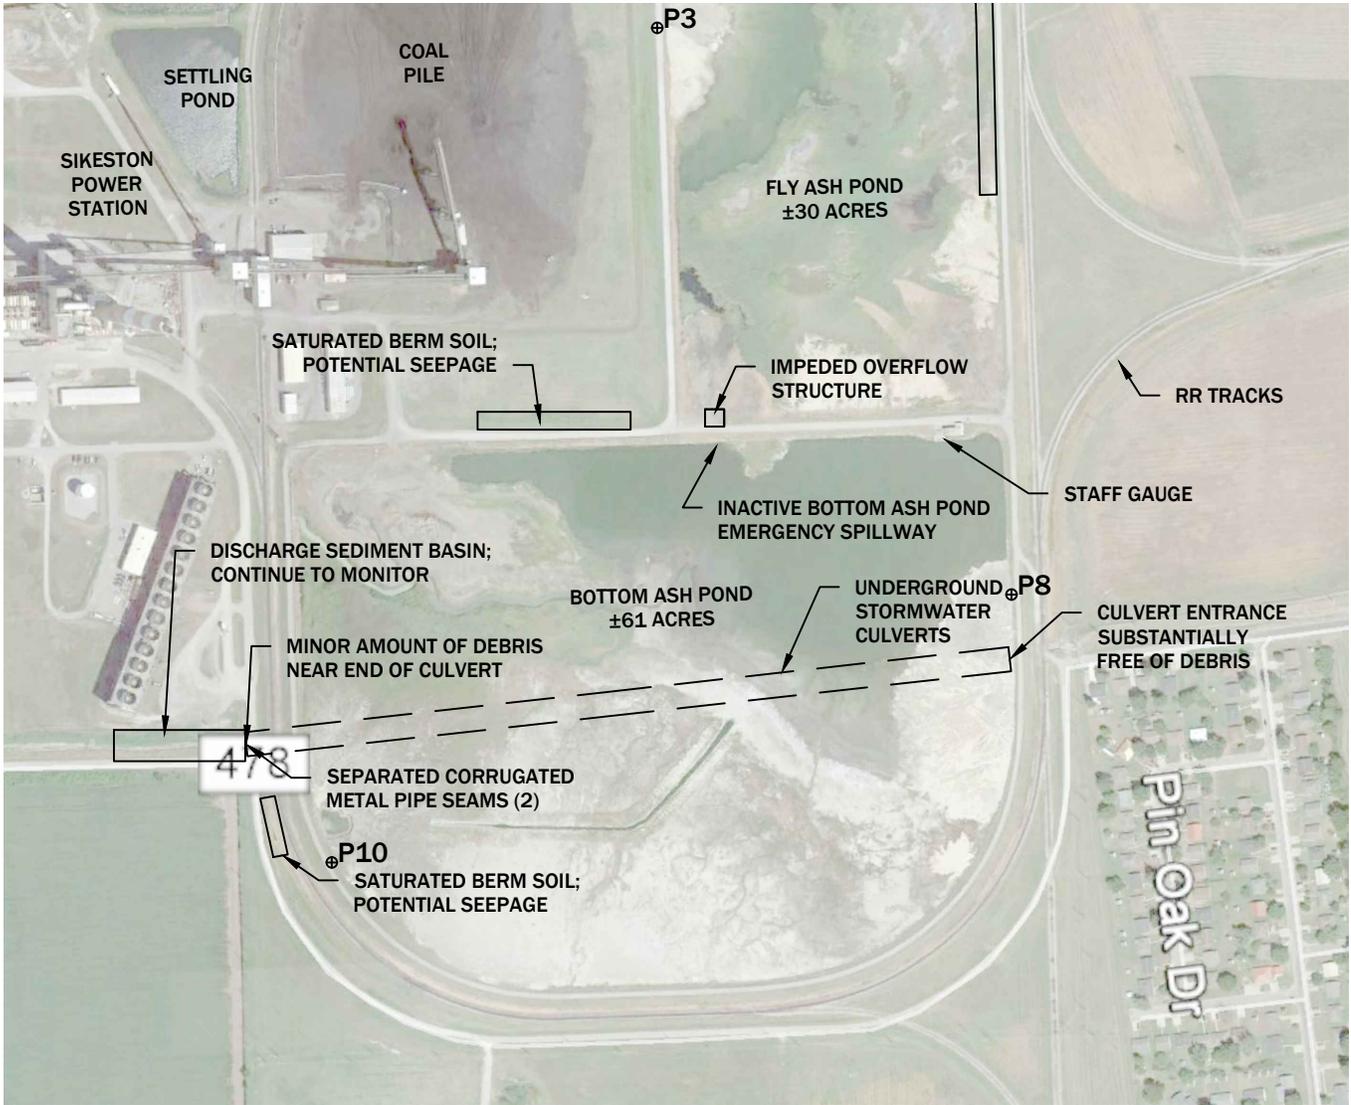
FIGURE 1

Earth Embankment		
Item	Condition Code	Comments
Vertical & Horizontal Alignment of Crest	GC	No visible evidence of deformation of embankment.
Seepage/Wetness / Ponding Areas	OB (Ponding)	Water ponds occasionally in the perimeter flat bottom ditch inside rail loop. This appears to be caused by the flat grade of the railroad bed and does not appear to be seepage. The ponding restricts mowing (maintaining) the ditch during wet periods, but otherwise is not a concern.
	OB (Northern Berm Seepage)	An area along the northern berm of the Bottom Ash Pond, west of the Fly Ash Pond was identified as an area of potential seepage from the Bottom Ash Pond during prior inspections. No visual observation of erosion of the outer berm soils were observed in 2016 through 2020. 2020 observation indicates the area continues to be maintained. In mid-2018, Gredell Engineering subcontracted to Reitz & Jens, Inc. (St. Louis) to complete an evaluation of the area of the northern embankment of the Bottom Ash Pond. The report stated that the possible seepage did not have a negative impact on the stability of the embankments. Therefore, it is recommended that this area continue to be visually monitored to note any change in conditions. Future remediation of the wet area may be appropriate at a future date based on regulatory or other considerations.

OB (Southwest Berm Seepage)	A saturated area along the southwestern berm of the Bottom Ash Pond was observed during the annual inspection. The surficial soil in this area was identified to be soft and appeared wet in this area. No visual signs of erosion of the outer berm soils were observed in 2020 or during prior inspections. The area was able to be routinely maintained (i.e., mowed) and there was no evidence of rutting or other distress from mowing equipment observed in the area. Therefore, it is recommended that this area continue to be visually monitored to note any change in conditions. Future investigation of the wet area may be appropriate at a future date based on regulatory or other considerations.
Erosion/Rutting	MM	No evidence of erosion or rutting on the outside slopes of the berms were observed in 2020. However, weekly inspections noted minor rutting in gravel roads and ramps were noted in the weekly inspections. A few minor potholes were observed on the gravel berm roads but the gravel ramps were in good condition during our annual inspection. The rutting appears to be caused by heavy truck traffic during periods of wet weather. While these ruts do not have the same significance as rutting and erosion on the outside slopes of the berms, they should be corrected to maintain a consistent vertical height of the perimeter berms. SBMU staff periodically remediated the conditions noted by grading the road surfaces and adding gravel where necessary.

1. ITEMS REQUIRING FURTHER OBSERVATION, INVESTIGATION OR CORRECTIVE ACTION INCLUDE:
 - a. SATURATED BERM SOIL ALONG NORTHERN BERM, WEST OF THE FLY ASH POND. (SAME AS 2019)
 - b. SEPARATED CORRUGATED METAL PIPE SEAMS AT THE DISCHARGE OF THE SOUTHERN STORMWATER CULVERT PASSING BENEATH THE BOTTOM ASH POND. (SAME AS 2019. REPORTED NOT REPAIRED)
 - c. GRASS LINED CHANNEL AT THE DISCHARGE OF THE STORMWATER AT THE OUTLET OF THE STORMWATER CULVERTS PASSING BENEATH THE BOTTOM ASH POND FROM EAST TO WEST HAS BEEN CLEARED OF BRUSH AND EXCAVATED TO CREATE A SEDIMENT BASIN. BASIN PARTIALLY FILLED WITH SEDIMENT AND DEBRIS. RE-EXCAVATE AS NEEDED.
 - d. SATURATED BERM SOIL ON SOUTHWEST BERM.
2. ITEMS IDENTIFIED DURING THE ANNUAL INSPECTION WHICH DO NOT REQUIRE MAINTENANCE:
 - a. THE IMPEDED OVERFLOW STRUCTURE BETWEEN THE BOTTOM ASH POND AND THE FLY ASH POND.
