Checklist for P.E. Annual Inspection for CCR Surface Impoundments, § 257.83(b)

Sikeston BMU Sikeston Power Station Fly Ash Surface Impoundment

Annual Inspection

**2020 ANNUAL P.E. INSPECTION
FLY ASH POND
SIKESTON POWER STATION**

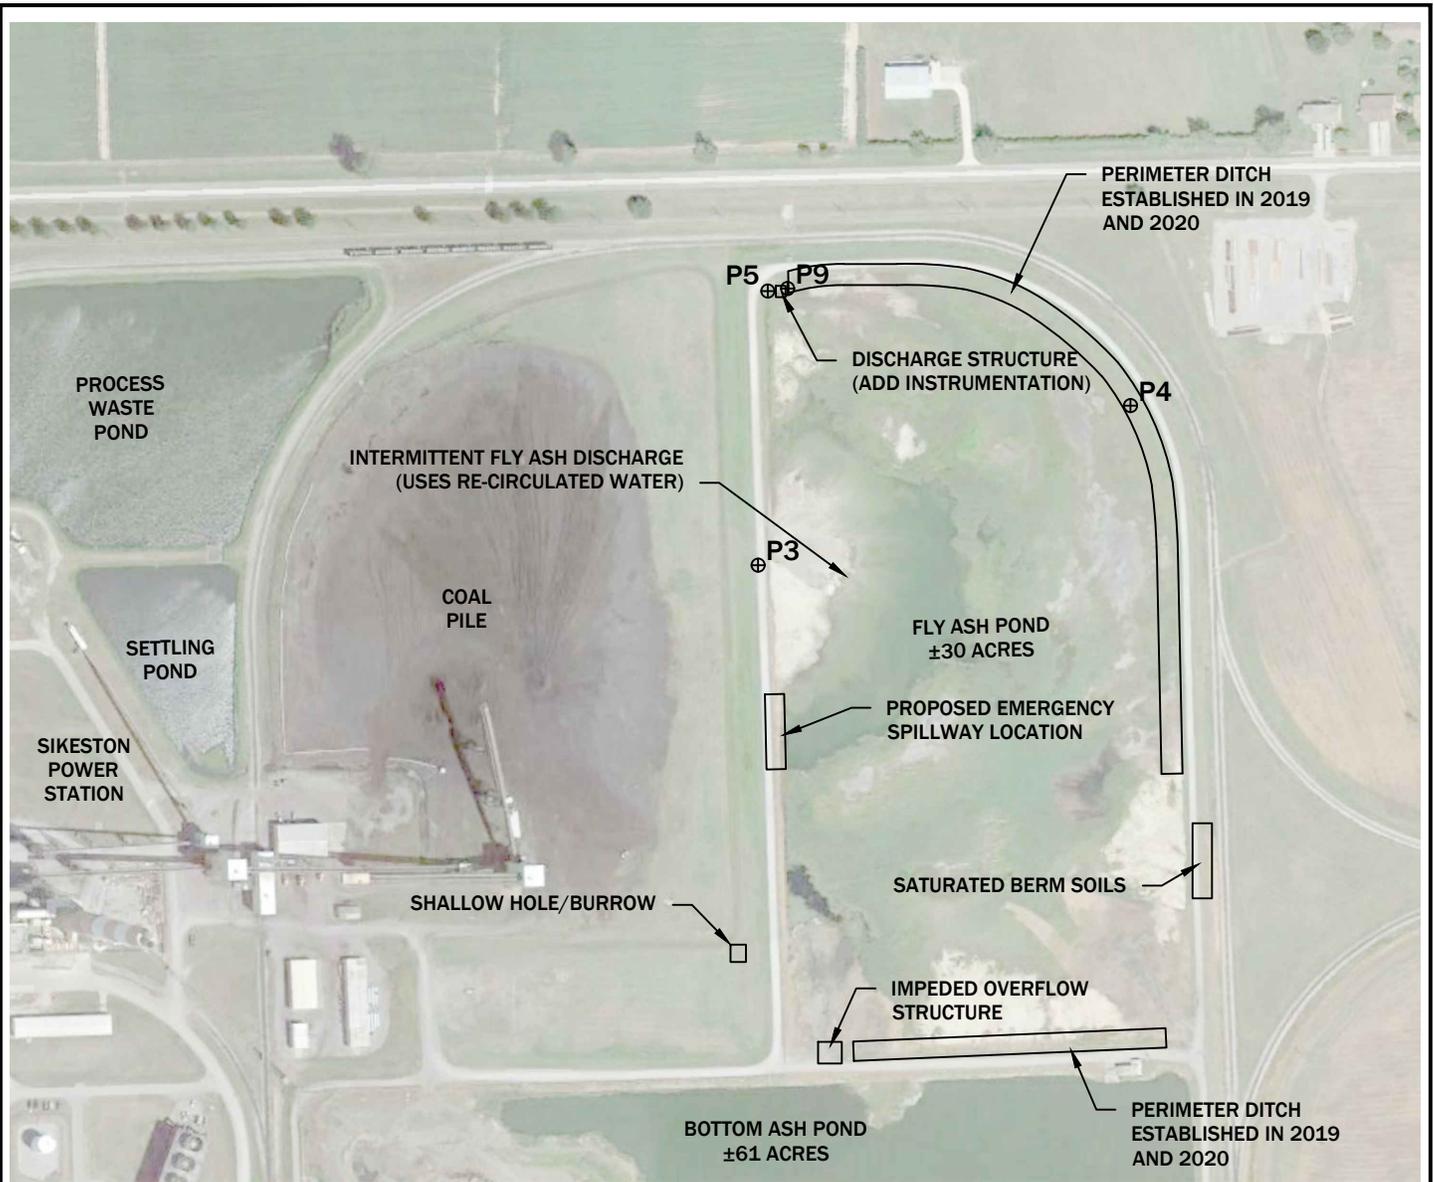
FIGURE 1

Inlet and Outlet Works		
Item	Condition Code	Comments
Outlet Condition	NE	The outlet structure has a concrete intake with stop logs. No stop logs were in place. The outlet structure discharges into one of two buried 24-inch pipes: one pipe discharges north and offsite the property; and one pipe discharges west and then follows an open channel swale to Process Waste Pond.
Gate Condition/ Operability	NE	Stop logs originally controlled water level, but are not in place and no longer used. Two gate valves originally provide flow control. Both discharges are reported to be permanently sealed. Gredell Engineering has recommended that the gate valve that discharges to the west (toward the Process Waste Pond) be repaired and returned to operable condition. The gate valve could be left sealed if an emergency spillway is constructed.
Leakage	NE	No leakage from the outlet structure was observed.
Outfall Condition	MM	The pond system outfall structure discharge pipes are currently reported to be permanently sealed. Gredell Engineering has recommended that the gate valve that discharges to the west into the Process Waste Pond be returned to operable condition. The gate valve could be left sealed if an emergency spillway is constructed.

Earth Embankment		
Item	Condition Code	Comments
Vertical & Horizontal Alignment of Crest	GC	No visible evidence of deformation of embankment has been observed.
Seepage/Wetness / Ponding Areas	OB (Seepage)	An area along the exterior of the southeastern berm of the Fly Ash Pond was identified as an area of potential seepage from the Fly Ash Pond. The wet area was previously identified as an area of potential seepage based on the presence of a small number of cattails a few feet up the slope from the perimeter stormwater ditch inside of the railroad loop. Cattails were not observed, nor were signs of erosion of the outer berm soils during our annual inspection. The area was able to be maintained (the vegetation had been recently cut). In mid-2018, Gredell Engineering subcontracted to Reitz & Jens, Inc. (St. Louis) to complete an evaluation of a small localized area of the southeast embankment of the Fly Ash Pond. The report stated that the possible seepage did not have a negative impact on the stability of the embankments. Therefore, it is recommended that this area continue to be visually monitored to note any change in conditions. Future remediation of the wet area may be appropriate at a future date based on regulatory or other considerations.

Erosion/Rutting	NE	No evidence of erosion or rutting on the outside slopes of the berms were observed in 2020. However, weekly inspections note that rutting and potholes periodically existed in the road surfaces located on top of the Fly Ash Pond berms. A few small potholes were observed along the roadway berms during the

annual inspection. The rutting appears to be caused by heavy truck traffic during periods of wet weather, and should be corrected to maintain a consistent vertical height of the perimeter berms. SBMU staff periodically remediated the conditions noted by grading the road surfaces.
Fencing	GC	Fencing is only adjacent to the Fly Ash Surface Impoundment on the north perimeter. The fencing is a not located on the toe of the berms. The fencing is in very good condition.
Vegetation	GC	Vegetation on exterior slopes was periodically cut and maintained during 2020 as evidenced by Gredell Engineering’s inspection and weekly inspection reports by plant personnel. However, the portion of the rule that requires vegetation to be kept at 6 inches or less has been remanded.
Sloughs/Slides/ Cracks	NE	No evidence was observed in 2020.
Animal Control	OB	A small, shallow hole was observed in the west embankment, just north of the Bottom Ash Pond. A weekly inspection report indicated a coyote was observed near the ash pond. The small hole did not appear to be a burrow and may have been dug by the coyote or other animal. Evidence of burrowing animals was not observed. SBMU staff should continue to monitor for burrowing animals and attempt to remove such animals from the area.

1. The location of observations on attached plan sheet (Figure 1).

1. MINOR MAINTENANCE ITEMS INCLUDE:
 - a. CLEAN SEDIMENT AND VEGETATION FROM DISCHARGE STRUCTURE.
 - b. ADD INSTRUMENTATION (STAFF GAUGE).
 - c. REPAIR INOPERABLE GATE VALVE TO THE PROCESS WATER POND OR DEVELOP AN EMERGENCY SPILLWAY.
 - d. EXCAVATE INTERIOR STORMWATER CHANNEL 2 FEET DEEP ALONG POND PERIMETER (WHERE REQUIRED)
2. REQUIRING FURTHER OBSERVATION INCLUDE:
 - a. SATURATED BERM SOIL ALONG SOUTHEAST BERM.
 - b. MONITOR FOR BURROWING ANIMALS AND REMOVE THEM AS NEEDED.
3. ITEMS IDENTIFIED DURING THE ANNUAL INSPECTION WHICH DO NOT REQUIRE MAINTENANCE:
 - a. THE IMPEDED OVERFLOW STRUCTURE BETWEEN THE BOTTOM ASH POND AND THE FLY ASH POND.
