**STRUCTURAL STABILITY
ASSESSMENT**

Sikeston Board of Municipal Utilities Sikeston Power Station Bottom Ash Pond Structural Stability Assessment

October 15, 2021

**Sikeston Board of Municipal Utilities
Sikeston Power Station
Bottom Ash Pond
Periodic Structural Stability Assessment**

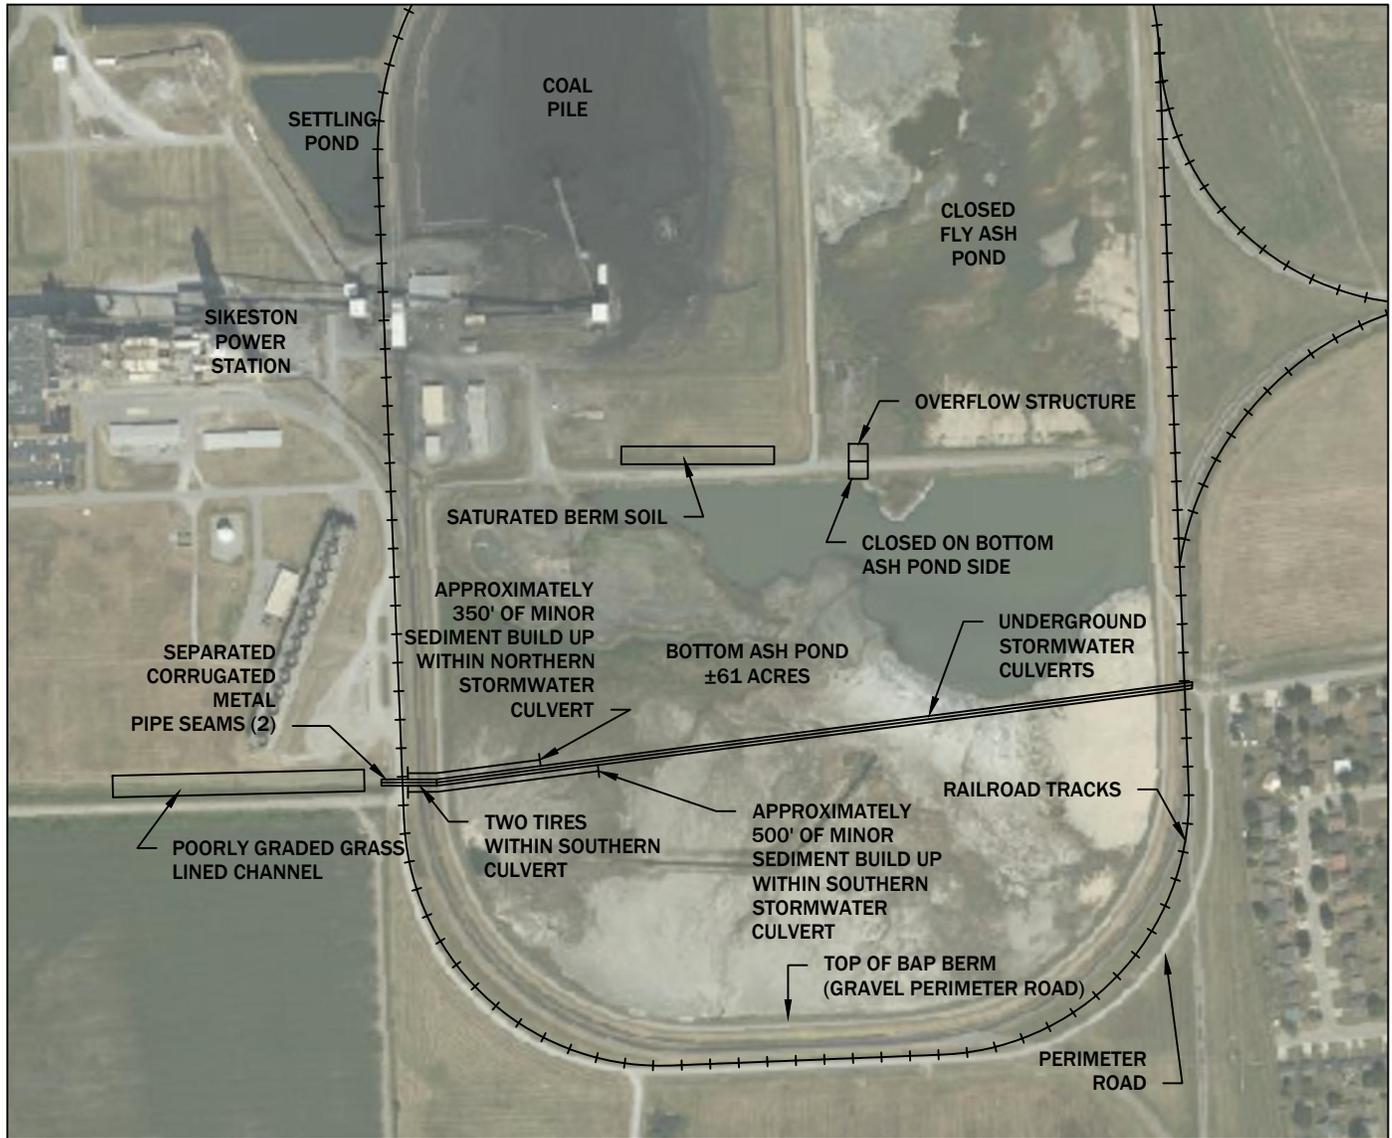
A visual inspection of the berms of the Bottom Ash Pond completed on September 16, 2021 identified an area of saturated soil along the northern berm of the Bottom Ash Pond and west of the Fly Ash Pond. The area was previously identified by SPS personnel as an area of persistent wet conditions from rainfall due to the lack of drainage along the toe of the slope of the Bottom Ash Pond. It was also identified by Gredell Engineering in 2016 during the initial Structural Stability Assessment and has also been noted annually by Gredell Engineering during annual pond inspections. The wet ground conditions have been observed to begin approximately midway on the exterior slope of the berm (approximate elevation of 314 feet) and continued to the toe of the exterior slope of the berm. The type of grass vegetation has been visually observed to change along a horizontal line along the exterior slope of the berm that generally matched the beginning of the wet conditions. Simple manual field techniques were also used to confirm the observations and conclusion of the wet conditions.

The Bottom Ash Pond was built with a second overflow structure that includes a concrete inlet on the north berm of the pond that connects to a 30-inch corrugated metal discharge pipe that flows north through the berm and originally discharged in the inactive Fly Ash Pond. The overflow structure originally discharged into the inactive Fly Ash Pond. However, the overflow structure is currently inoperable due to excess CCR deposits within the inactive Fly Ash Pond that obstruct the north (discharge) end of the 30-inch pipe. This condition has been noted during site inspections in the past.

- Overflow Structure: 30-inch corrugated metal pipe passing through the northern berm between the Bottom Ash Pond and the Fly Ash Pond (approximate 318.25 feet invert elevation). ***The invert elevation of this pipe was observed to be above the pond elevation on September 16, 2021.***
- Primary Discharge Pipe: 10-inch carbon fiber pipe passing through the northern berm of the Bottom Ash Pond, discharging into the Process Waste Pond (approximate 314.5 feet invert elevation).
- Makeup Water Inlet: 8-inch iron pipe passing through the northern berm of the Bottom Ash Pond from the Fly Ash Pond (approximate 321.5 feet invert elevation).

- **Overflow Structure:** The concrete headwall of the overflow structure was in good condition with no visual signs of deterioration. The iron shear gate and inlet of the 30-inch corrugated metal pipe appeared to be in good condition with no visual signs of deterioration. The discharge of the 30-inch corrugated metal pipe was not identified due to buried by excessive CCR accumulation at the discharge end in the inactive the Fly Ash Pond. The excessive CCR accumulation negates the functionality of the overflow structure. The inoperable overflow structure is not determined to be a deficiency because the active discharge structure adequately manages flow during and following the peak discharge from the design flood event (the 1,000-year flood). The overflow structure also sits at an elevation generally above the normal operating pool of the Bottom Ash Pond.

minimal deterioration. The southern stormwater culvert remains in good condition except for two locations previously noted where seams near the top of the corrugated metal pipe have separated. The bituminous lining of both the corrugated metal culverts has deteriorated and the long-term potential is that the metal culverts may deteriorate over time. The separated seams of the southern stormwater culvert are identified as a deficiency. However, it is noted that the approximately 50 feet of corrugated pipe is located outside of the footprint of the actual Bottom Ash Pond. So long-term deterioration of the metal culvert is not expected to cause a release from the Bottom Ash Pond. But the long-term deterioration of the southern metal culvert pipe section could result in a significant reduction in the hydraulic capacity of the southern culvert, resulting in potential inundation of the culverts.

- Repair the separated seams of the corrugated metal pipe section in the southern stormwater culvert.
