Checklist for P.E. Annual Inspection for CCR Surface Impoundments, § 257.83(b)

Sikeston BMU Sikeston Power Station Bottom Ash Surface Impoundment

Annual Inspection

**2016 ANNUAL PE INSPECTION
BOTTOM ASH POND
SIKESTON POWER STATION**

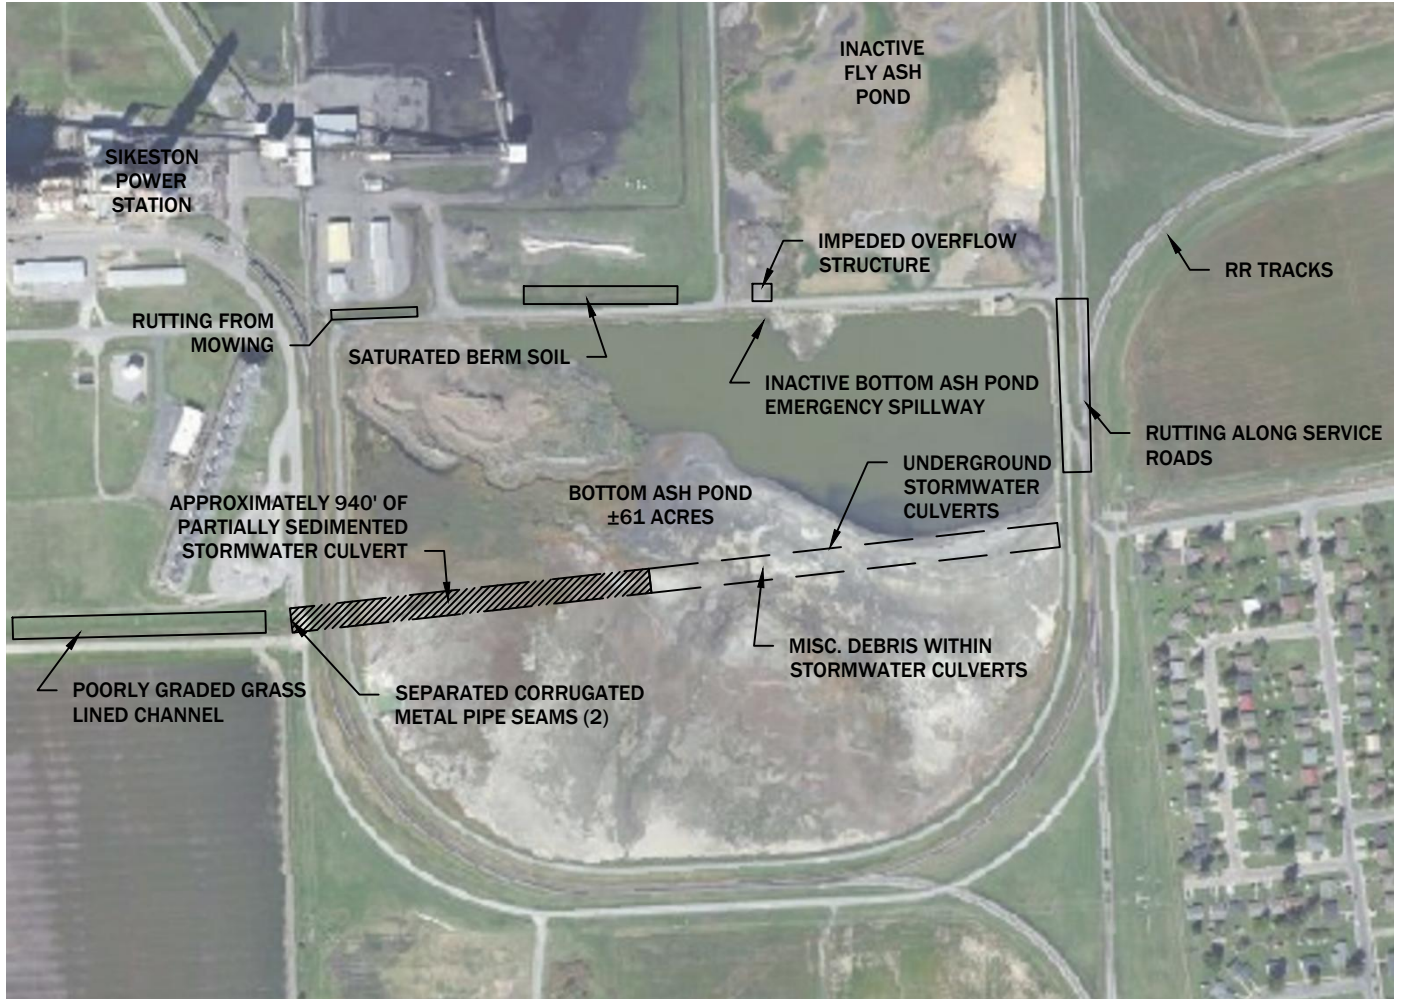
FIGURE 1

1. MINOR MAINTENANCE ITEMS INCLUDE RUTTING FROM MOWING AND RUTTING ALONG SERVICE ROADS
2. ITEMS REQUIRING FURTHER INVESTIGATION AND/OR CORRECTIVE ACTION INCLUDE:

- a. SATURATED BERM SOIL ALONG NORTHERN BERM, WEST OF THE INACTIVE FLY ASH POND
 - b. PARTIALLY SEDIMENTED STORMWATER CULVERTS (2) PASSING BENEATH THE BOTTOM ASH POND FROM EAST TO WEST.

- c. SEPARATED CORRUGATED METAL PIPE SEAMS AT THE DISCHARGE OF THE SOUTHERN STORMWATER CULVERT PASSING BENEATH THE BOTTOM ASH POND.
 - d. POORLY GRADED GRASS LINED CHANNEL AT THE DISCHARGE OF THE STORMWATER AT THE OUTLET OF THE STORMWATER CULVERTS PASSING BENEATH THE BOTTOM ASH POND FROM EAST TO WEST.

3. ITEMS IDENTIFIED DURING THE ANNUAL INSPECTION WHICH DO NOT REQUIRE MAINTENANCE INCLUDE MISCELLANEOUS DEBRIS WITHIN THE STORMWATER CULVERTS PASSING BENEATH THE BOTTOM ASH POND (E.G. TIRES AND RIP RAP) AND THE IMPEDED OVERFLOW STRUCTURE BETWEEN THE BOTTOM ASH POND AND THE INACTIVE FLY ASH POND.
