Checklist for P.E. Annual Inspection for CCR Surface Impoundments, § 257.83(b)

Sikeston BMU Sikeston Power Station Bottom Ash Surface Impoundment

Annual Inspection

**SIKESTON POWER STATION – BOTTOM ASH POND
2022 ANNUAL INSPECTION CHECK SHEET**

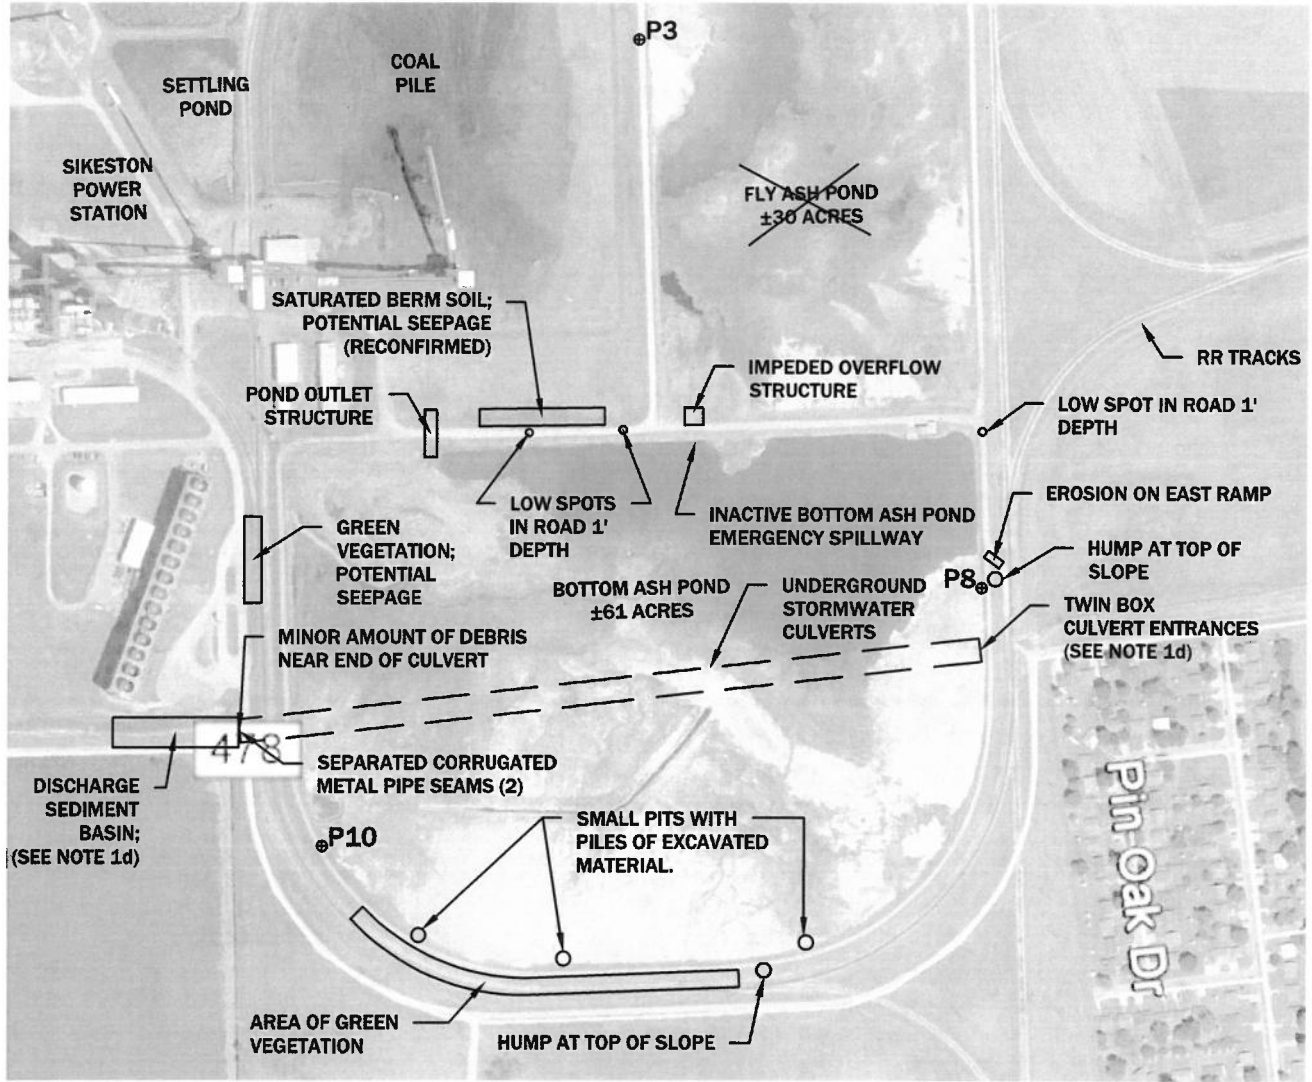
**FIGURE 1
2022 ANNUAL INSPECTION
BOTTOM ASH POND**

1. IMMEDIATE MAINTENANCE ITEMS INCLUDE:
 - a. MINOR EROSION OF EXTERIOR ACCESS RAMP ON THE NORTHEAST BERM.
 - b. TWO LOW SPOTS IN THE BERM ROAD ON THE NORTH BERM EAST OF THE FLY ASH POND AND ONE LOW SPOT NEAR THE NORTHEAST CORNER OF THE BERM ROAD.

2. ITEMS REQUIRING FURTHER OBSERVATION INCLUDE:
 - a. SATURATED BERM SOIL ALONG NORTHERN BERM, WEST OF THE FLY ASH POND. (CONDITIONS ARE UNCHANGED SINCE 2016)

- b. GREEN VEGETATION (DURING DROUGHT YEAR) ON WESTERN AND SOUTHWESTERN BERM SLOPES INDICATE POSSIBLE SEEPAGE. CONTINUED OBSERVATION AND MONITORING RECOMMENDED.

- c. SEPARATED CORRUGATED METAL PIPE SEAMS AT THE DISCHARGE END OF THE SOUTHERN STORMWATER CULVERT PASSING BENEATH THE BOTTOM ASH POND. (CONDITIONS ARE UNCHANGED SINCE 2016)

- d. GRASS LINED CHANNEL AT THE OUTLET OF THE STORMWATER CULVERTS PASSING BENEATH THE BOTTOM ASH POND FROM EAST TO WEST REMAINS CLEAR OF BRUSH. THE SEDIMENT BASIN IS PARTIALLY FILLED WITH SEDIMENT AND DEBRIS. RE-EXCAVATION OF THE SEDIMENT BASIN IS RECOMMENDED IN 2023.

- e. TWIN BOX CULVERT VIDEO INSPECTION WAS COMPLETED IN 2021 TO VERIFY STRUCTURAL STABILITY.
3. ITEMS IDENTIFIED DURING THE ANNUAL INSPECTION WHICH DO NOT REQUIRE MAINTENANCE:

- a. THE HISTORICALLY IMPEDED OVERFLOW STRUCTURE BETWEEN THE BOTTOM ASH POND AND THE FLY ASH POND.
