2022 Checklist for P.E. Annual Inspection for CCR Surface Impoundments, § 257.83(b)

**Sikeston BMU Sikeston Power Station Fly Ash Surface Impoundment**

**SIKESTON POWER STATION – FLY ASH POND  
2022 ANNUAL INSPECTION CHECK SHEET**

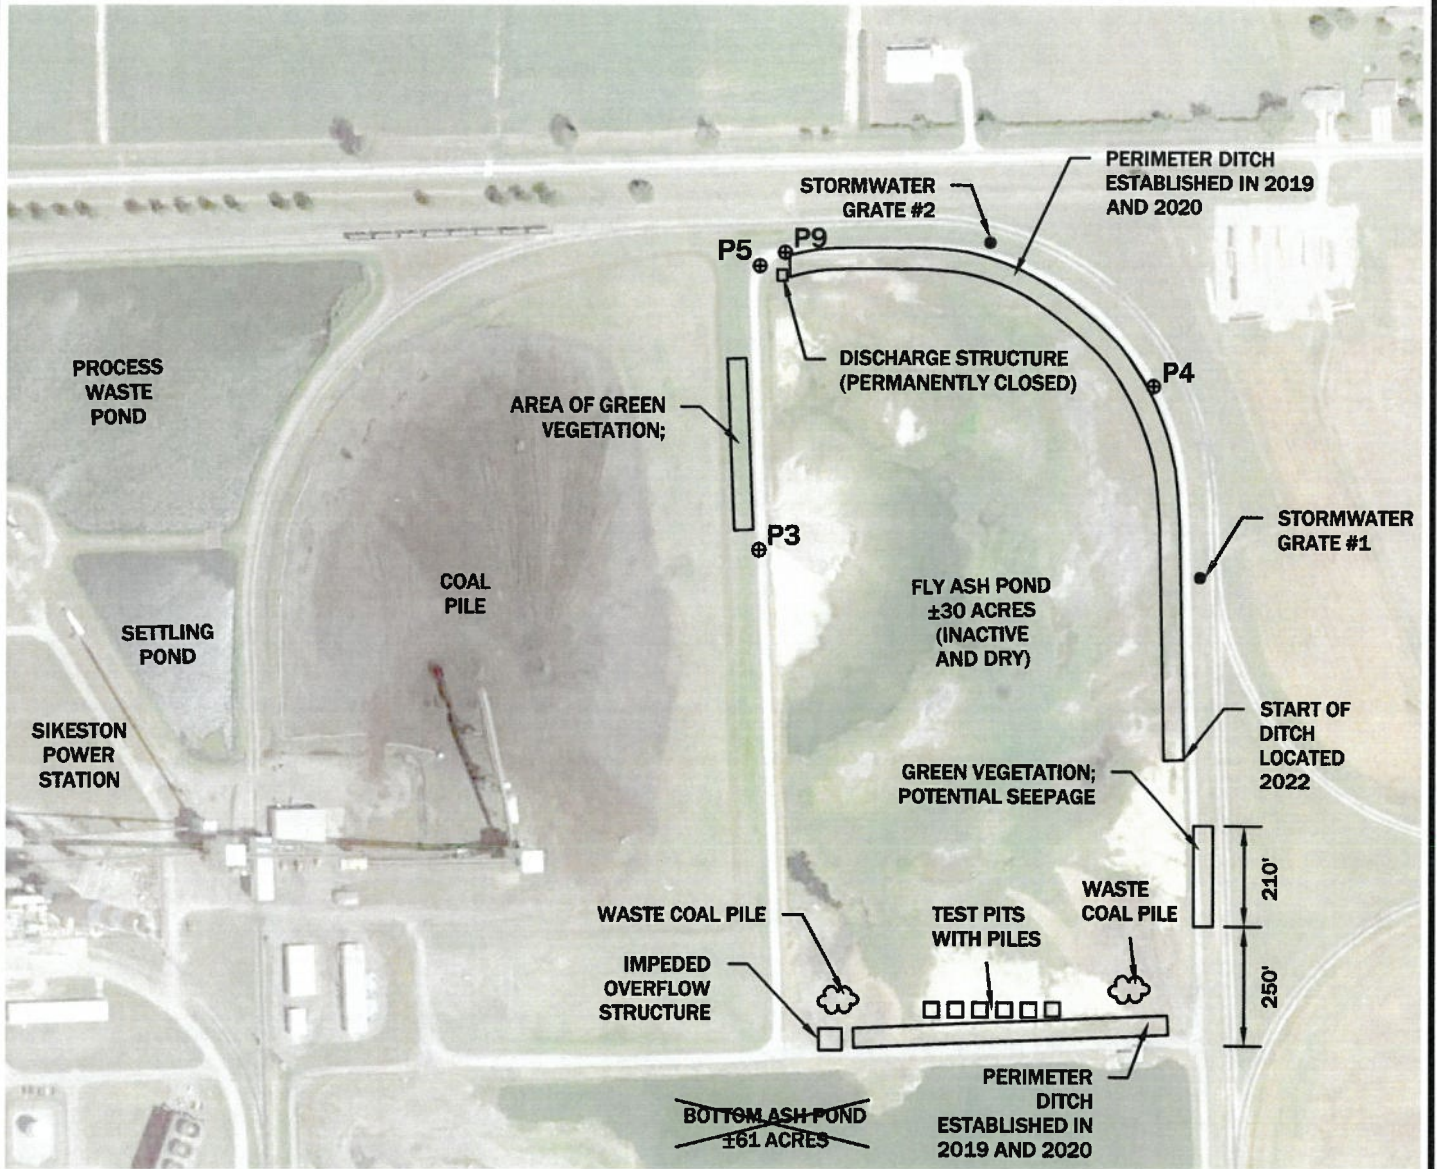
**FIGURE 1  
2022 ANNUAL INSPECTION  
FLY ASH POND**

2. ITEMS RECOMMENDED FOR CONTINUED OBSERVATION INCLUDE:
  - a. GREEN VEGETATION IN THE AREAS ALONG THE SOUTHEAST BERM AND NORTHWEST BERM INDICATES POSSIBLE SEEPAGE. CONTINUED OBSERVATION RECOMMENDED.

- b. NOTE ACCUMULATION OF PONDED RAINFALL IN LOW AREAS, STORMWATER CHANNELS AND AT THE NORTHWEST OUTLET STRUCTURE DURING WEEKLY INSPECTIONS.
  - c. PRESENCE OF BURROWING ANIMALS DURING MONTHLY INSPECTIONS. REMOVE AND REPAIR AS NEEDED.

3. ITEMS IDENTIFIED DURING THE ANNUAL INSPECTION WHICH DO NOT REQUIRE MAINTENANCE:
  - a. THE IMPEPED OVERFLOW STRUCTURE BETWEEN THE BOTTOM ASH POND AND THE FLY ASH POND.

- b. PERMANENTLY CLOSED DISCHARGE STRUCTURE.

1. MINOR MAINTENANCE ITEMS INCLUDE:
  - a. MAINTAIN EXCAVATED INTERIOR STORMWATER CHANNEL AT 2 FEET DEPTH ALONG POND PERIMETER (WHERE IT EXISTS OR IS REQUIRED)
