RE: SBMU Sikeston Power Station CCR Surface Impoundment
2023 Annual P.E. Inspection of Fly Ash Pond

Sikeston BMU Sikeston Power Station Fly Ash Surface Impoundment Annual Inspection

**SIKESTON POWER STATION – FLY ASH POND
2023 ANNUAL INSPECTION CHECK SHEET**

**FIGURE 1
2023 ANNUAL INSPECTION
FLY ASH POND**

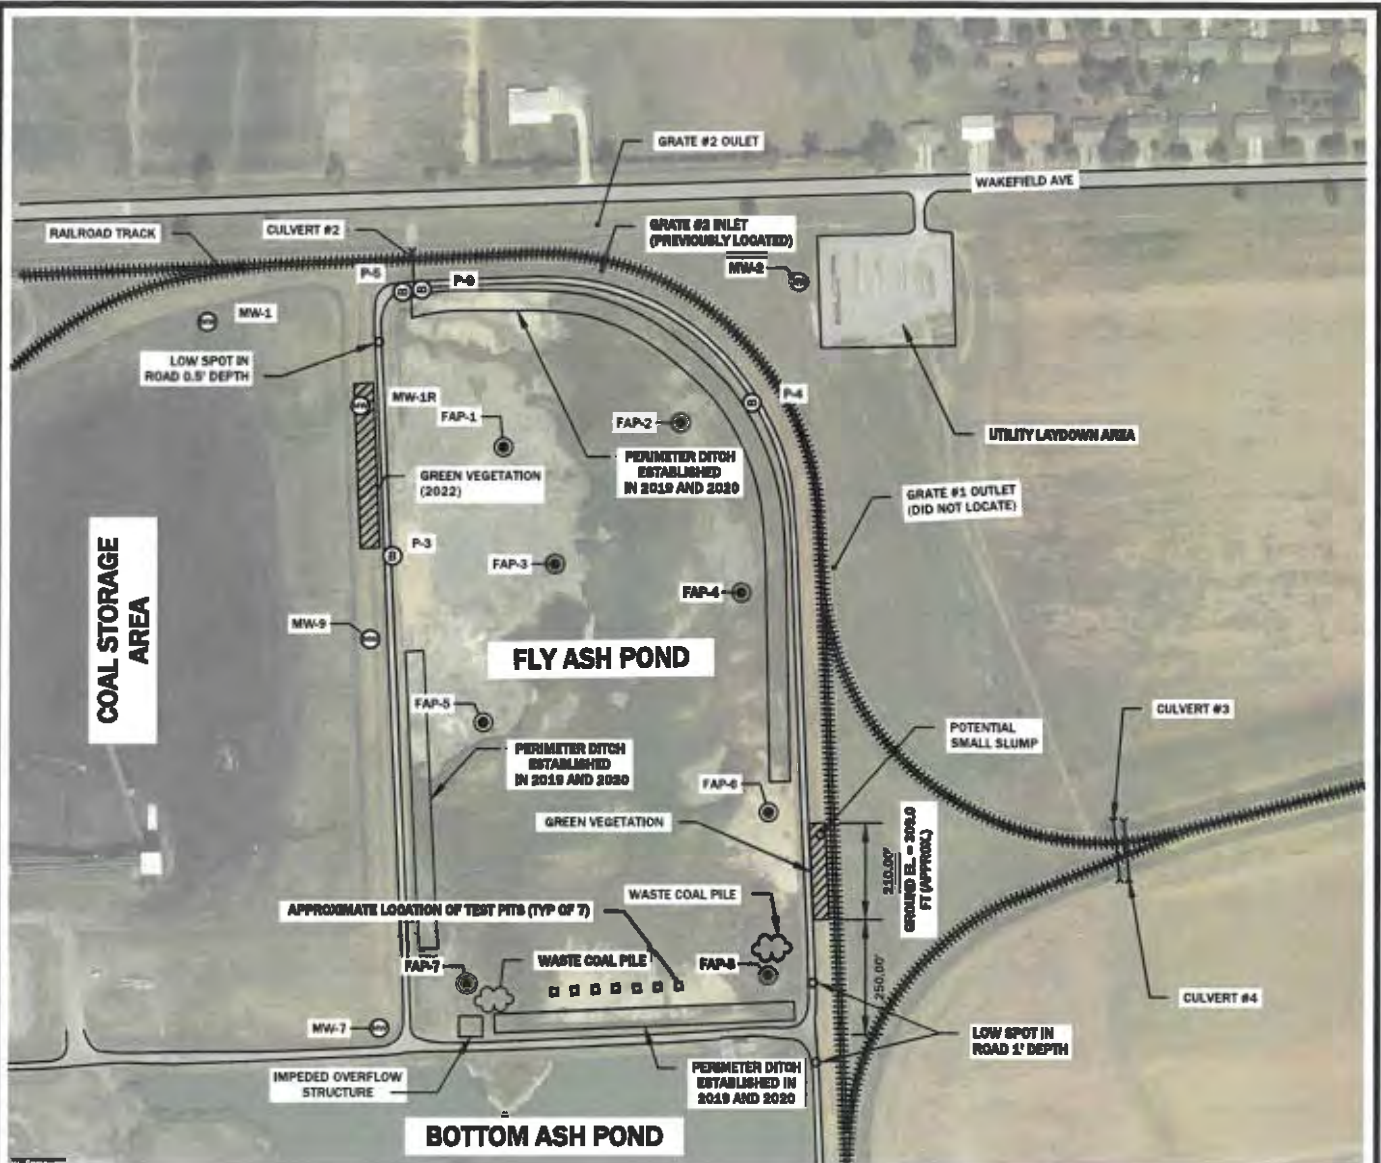
The 2023 Annual P.E. Inspection was performed by Thomas R. Gredell, P.E., and Wayne Elliott, E.I., GER. Items observed during the annual inspection that require further observation or minor maintenance investigation and/or corrective action are identified on Figure 1 of the 2023 Annual Inspection Check Sheets. Items observed on October 13, 2023, that require minor maintenance or further observation include:

1. MINOR MAINTENANCE ITEMS INCLUDE:
 - a. TWO LOW SPOTS IN THE BERM ROAD: ONE NEAR SOUTHEAST CORNER; AND ONE NEAR NORTHWEST CORNER.
 - b. MAINTAIN EXCAVATED INTERIOR STORMWATER CHANNEL AT 2 FEET DEPTH ALONG POND PERIMETER (WHERE IT EXISTS OR IS REQUIRED)

2. ITEMS RECOMMENDED FOR CONTINUED OBSERVATION INCLUDE:
 - a. GREEN VEGETATION IN THE AREAS ALONG THE SOUTHEAST BERM AND NORTHWEST BERM INDICATED POSSIBLE SEEPAGE. CONTINUED OBSERVATION RECOMMENDED.

- b. NOTE ACCUMULATION OF PONDED RAINFALL IN LOW AREAS, STORMWATER CHANNELS AND AT THE NORTHWEST OUTLET STRUCTURE DURING WEEKLY INSPECTIONS.
 - c. PERIODIC WATER LEVEL READINGS IN THE EIGHT (8) PIEZOMETERS INSTALLED WITHIN THE POND IN CCR MATERIALS. (PIEZOMETER LOCATIONS NOT SHOWN ON FIGURE)

3. ITEMS IDENTIFIED DURING THE ANNUAL INSPECTION WHICH DO NOT REQUIRE MAINTENANCE:
 - a. THE IMPEDED OVERFLOW STRUCTURE BETWEEN THE BOTTOM ASH POND AND THE FLY ASH POND.

- b. PERMANENTLY CLOSED DISCHARGE STRUCTURE.
4. PIEZOMETER LOCATIONS APPROXIMATED WITH HANDHELD GPS.
5. GRATE #1 INLET NOT IDENTIFIED.
