November 9, 2023

RE: Report of Periodic Safety Factor Assessment of Fly Ash Pond
Sikeston Board of Municipal Utilities (BMU) – Sikeston Power Station

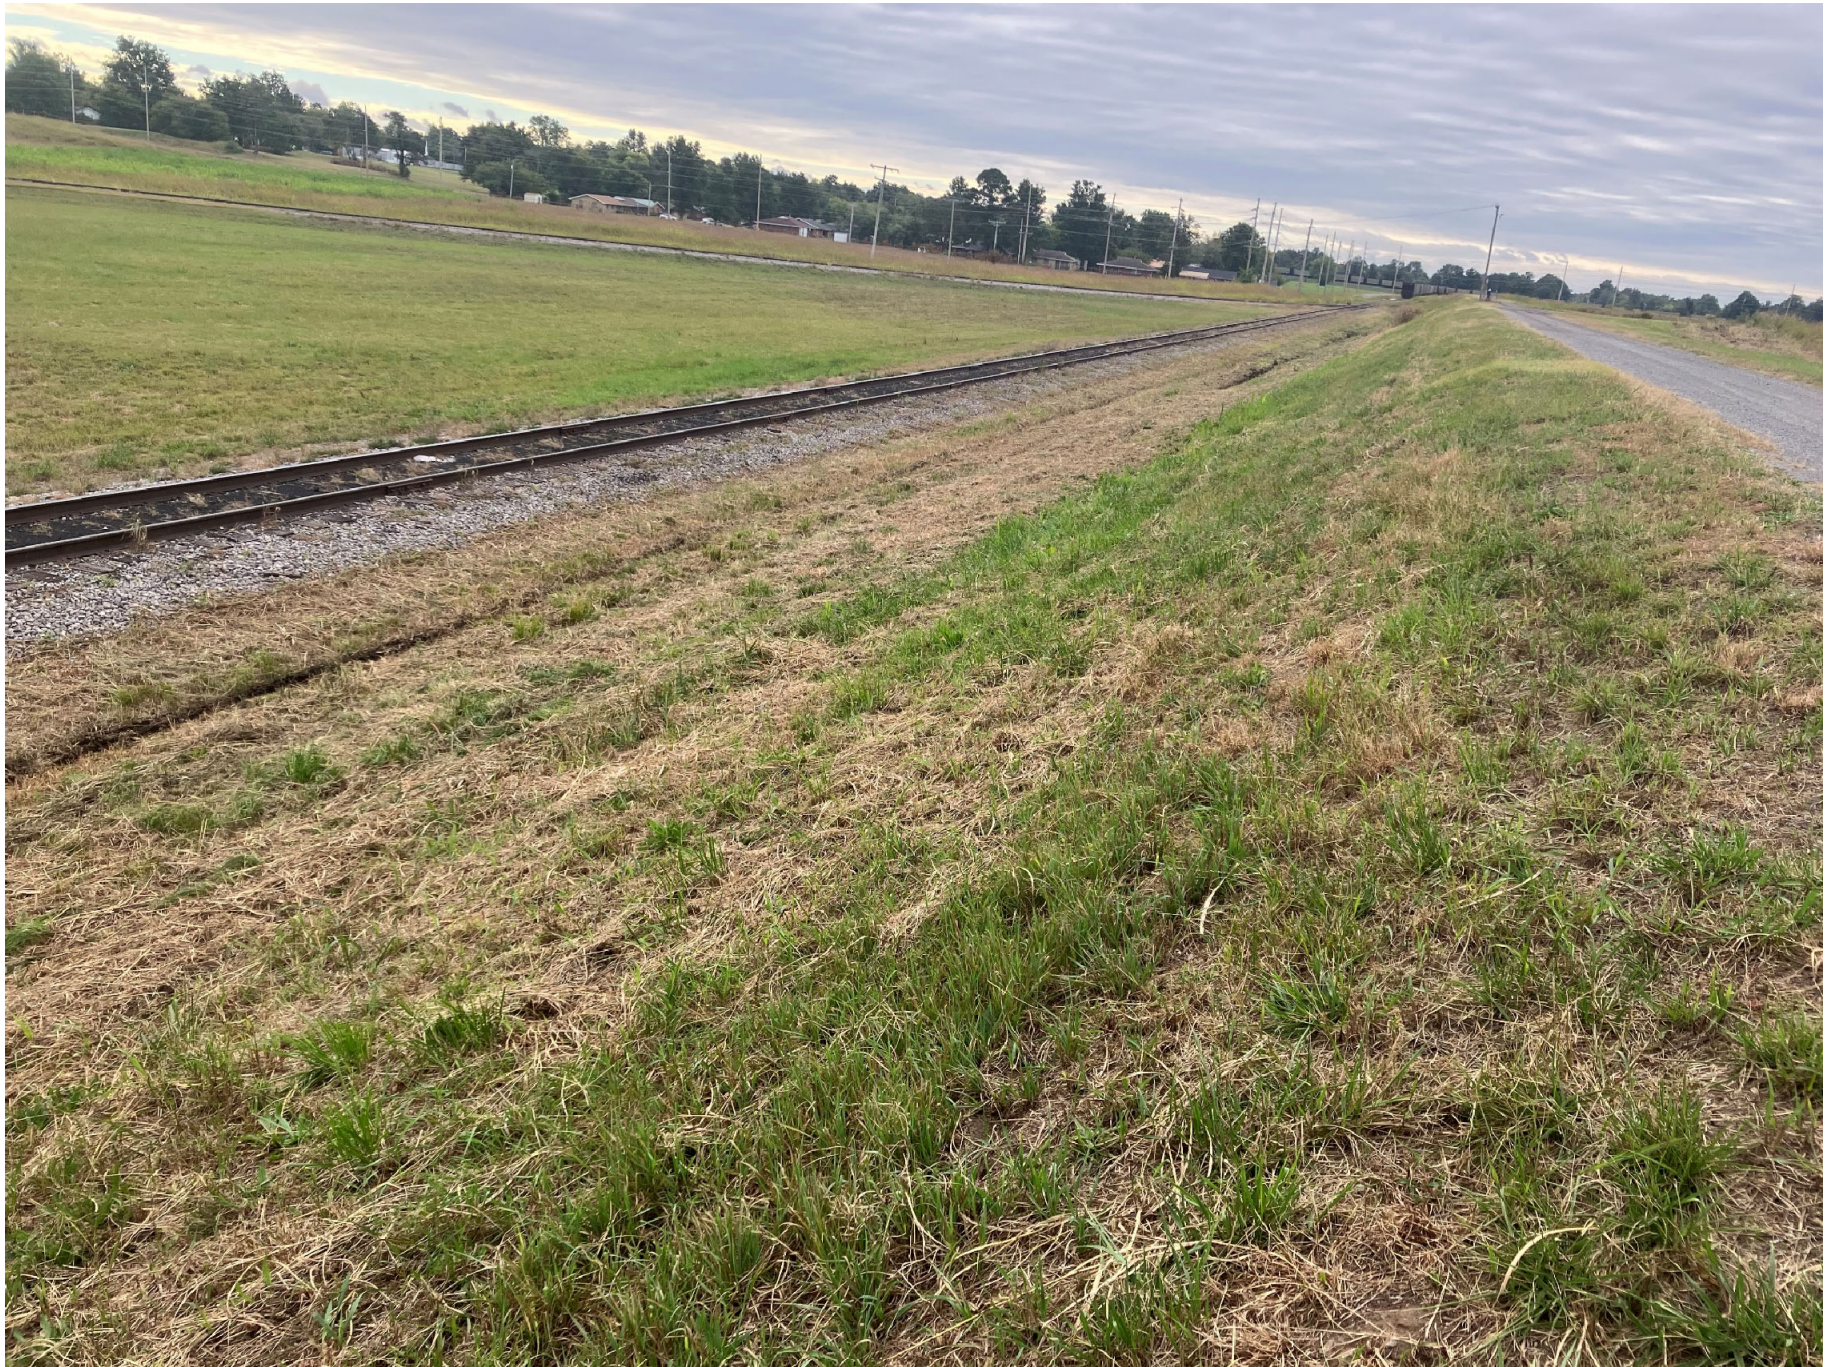
A portion of the shallow drainage ditch that had been dug along the north-south railroad track to the east of the Fly Ash Pond has collapsed (see attached photo). This portion is between the two turnouts that connect the railroad loop to the entrance track. The berm did not appear to be distorted by a slope failure or settlement. It appears that the ditch was filled by sloughing of the side of the ditch.

The critical failure surfaces of the slope stability analyses which we calculated previously did not extend beyond the toe of the east berm as far as the ditch. Therefore, we judged that the drainage ditch does not impact our findings of the Safety Factor Assessment performed in 2018. We recommend that a drain pipe be installed if the drainage ditch is re-dug to prevent sloughing.

Photo of Sloughing Along Drainage Ditch, East Berm of Fly Ash Pond. Note that berm slope and road appear unchanged. (10/13/2023)

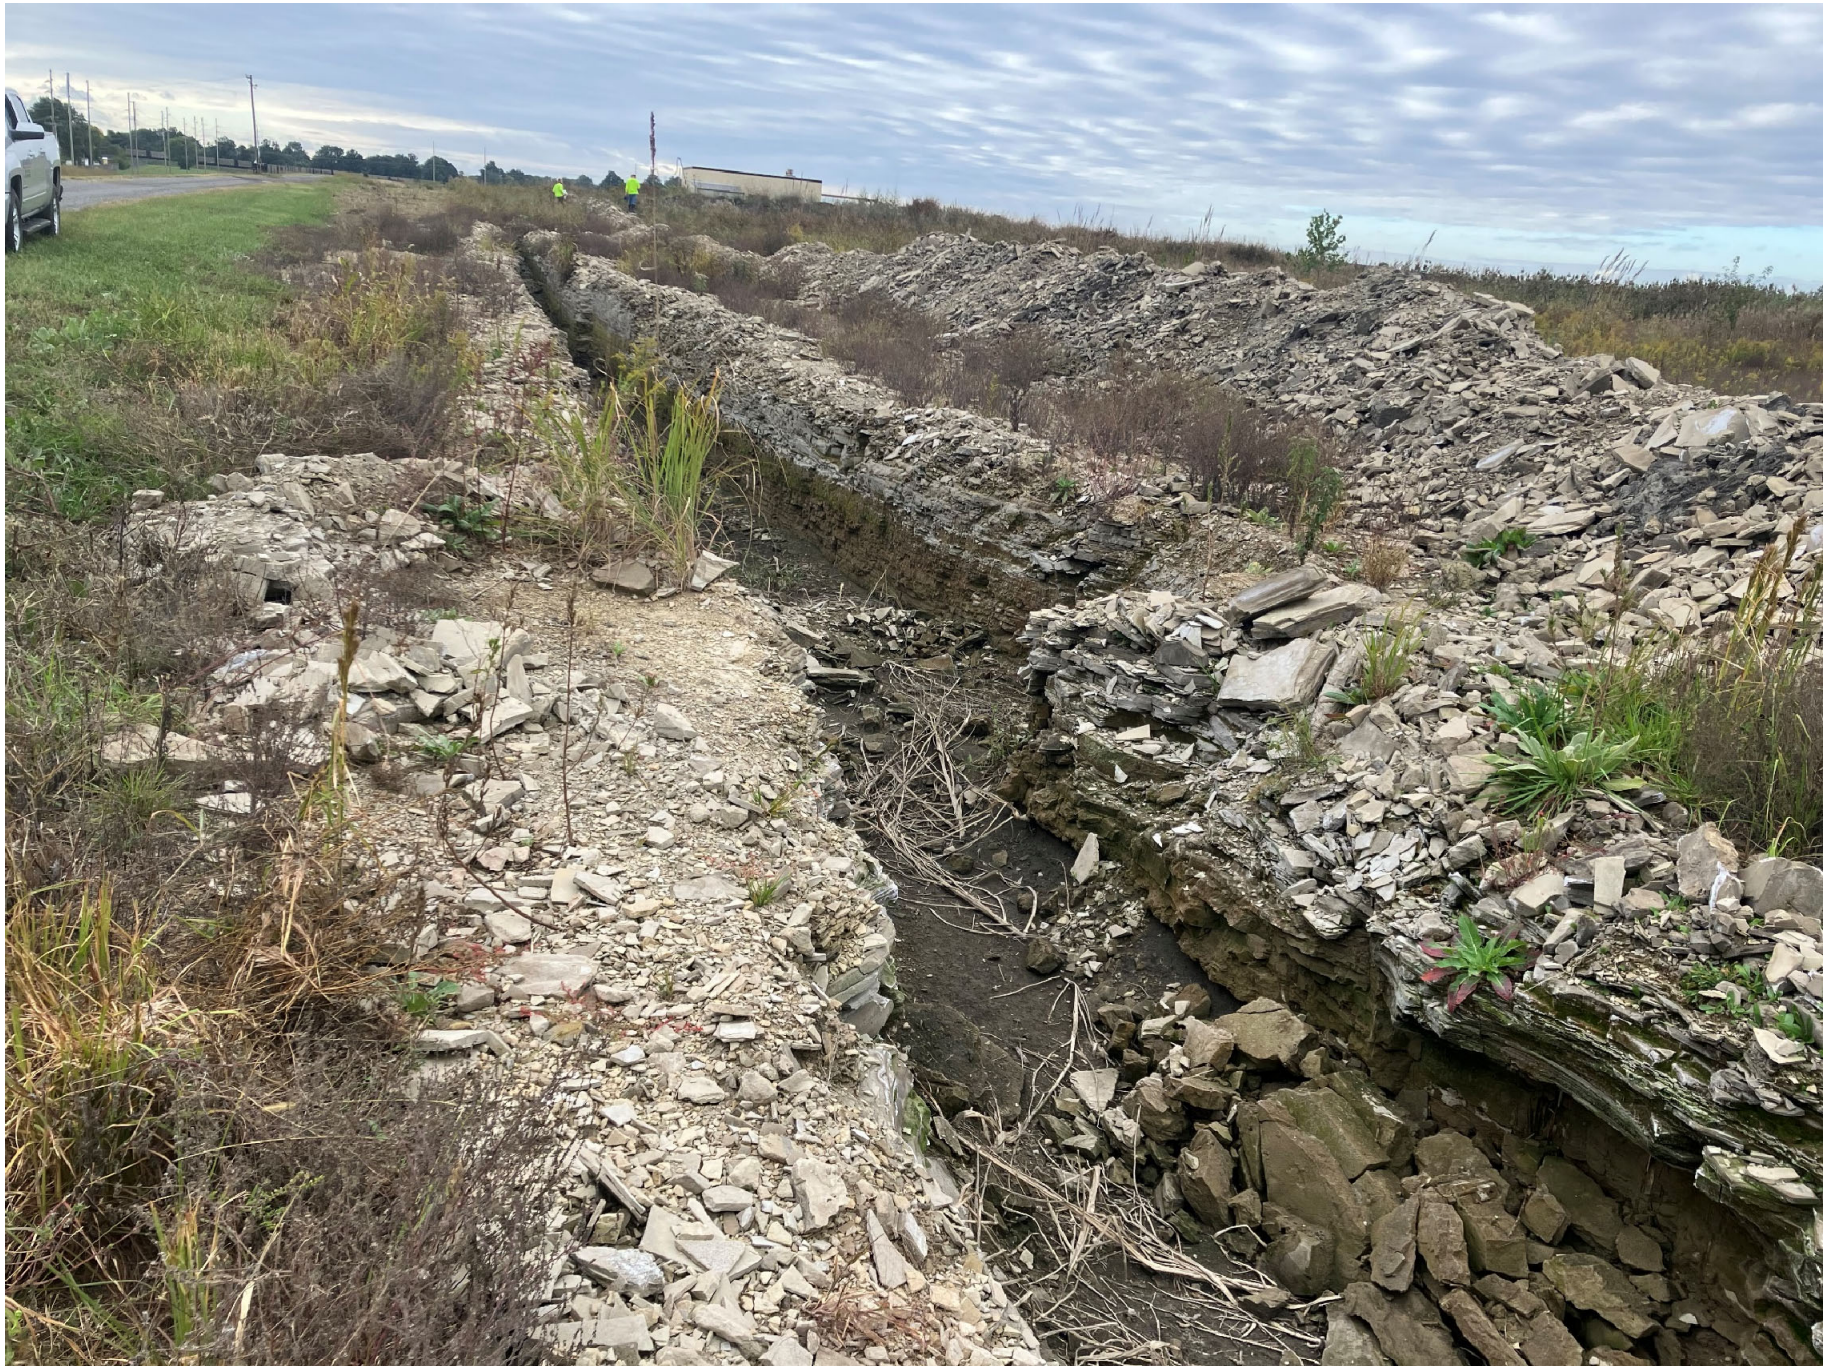
A drainage ditch has been excavated along the top of the east berm in the Fly Ash Pond (see attached photo). The ditch appears to be 4 or 5 feet deep; we did not measure it. The excavation revealed that approximately the upper 5 feet of fly ash has been solidified, forming hard laminated planes. We judge that the excavation of the drainage ditch does not impact our findings of the Safety Factor Assessment of the east berm if the ditch is well-drained. If the ditch is not well-drained, then seepage of the standing water in the ditch may increase seepage into the upper portion of the berm which could possibly decrease the stability of the slope. The fly ash excavated from the ditch is piled along the west side of the ditch inside the Fly Ash Pond. This does not have a significant impact on the stability of the east berm.

Photo of Excavation of Drainage Ditch Along East Berm of Fly Ash Pond. Note solidified fly ash in upper 5 feet. (10/13/2023)
