Sikeston BMU Sikeston Power Station Fly Ash Surface Impoundment

Annual Inspection

SIKESTON POWER STATION
Fly Ash Pond
Annual Inspection Check Sheet

**2018 INITIAL ANNUAL P.E. INSPECTION
FLY ASH POND
SIKESTON POWER STATION**

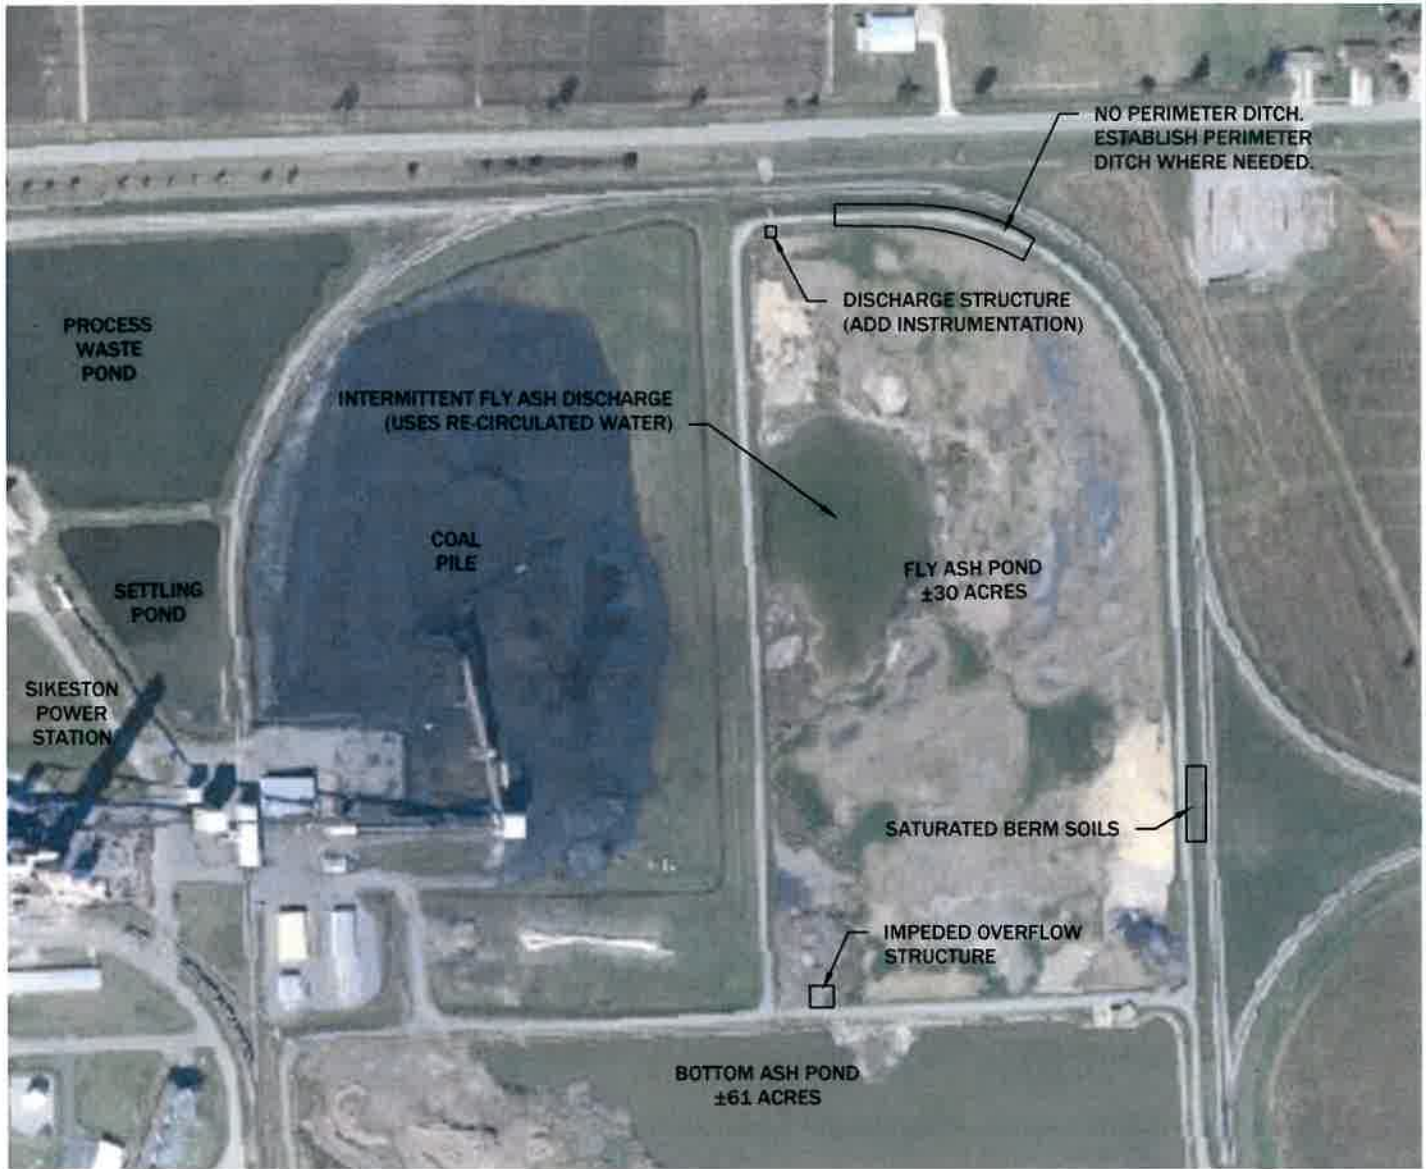
FIGURE 1

1. The location of observations on attached plan sheet (Figure 1).

1. MINOR MAINTENANCE ITEMS INCLUDE:
 - a. CLEAN SEDIMENT AND VEGETATION FROM DISCHARGE STRUCTURE.
 - b. ADD INSTRUMENTATION (STAFF GAUGE).
 - c. REPAIR INOPERABLE GATE VALVE TO THE PROCESS WATER POND.
 - d. EXCAVATE STORMWATER CHANNEL 2 FEET DEEP ALONG POND PERIMETER (WHERE REQUIRED)
2. REQUIRING FURTHER OBSERVATION INCLUDE:
 - a. SATURATED BERM SOIL ALONG SOUTHEAST BERM.
3. ITEMS IDENTIFIED DURING THE INITIAL INSPECTION WHICH DO NOT REQUIRE MAINTENANCE INCLUDE:
 - a. THE IMPEDED OVERFLOW STRUCTURE BETWEEN THE BOTTOM ASH POND AND THE INACTIVE FLY ASH POND.
