2021 Checklist for P.E. Annual Inspection for CCR Surface Impoundments, § 257.83(b)

### Sikeston BMU Sikeston Power Station Fly Ash Surface Impoundment

**SIKESTON POWER STATION – FLY ASH POND  
2021 ANNUAL INSPECTION CHECK SHEET**

**FIGURE 1  
2021 ANNUAL P.E. INSPECTION  
FLY ASH POND**

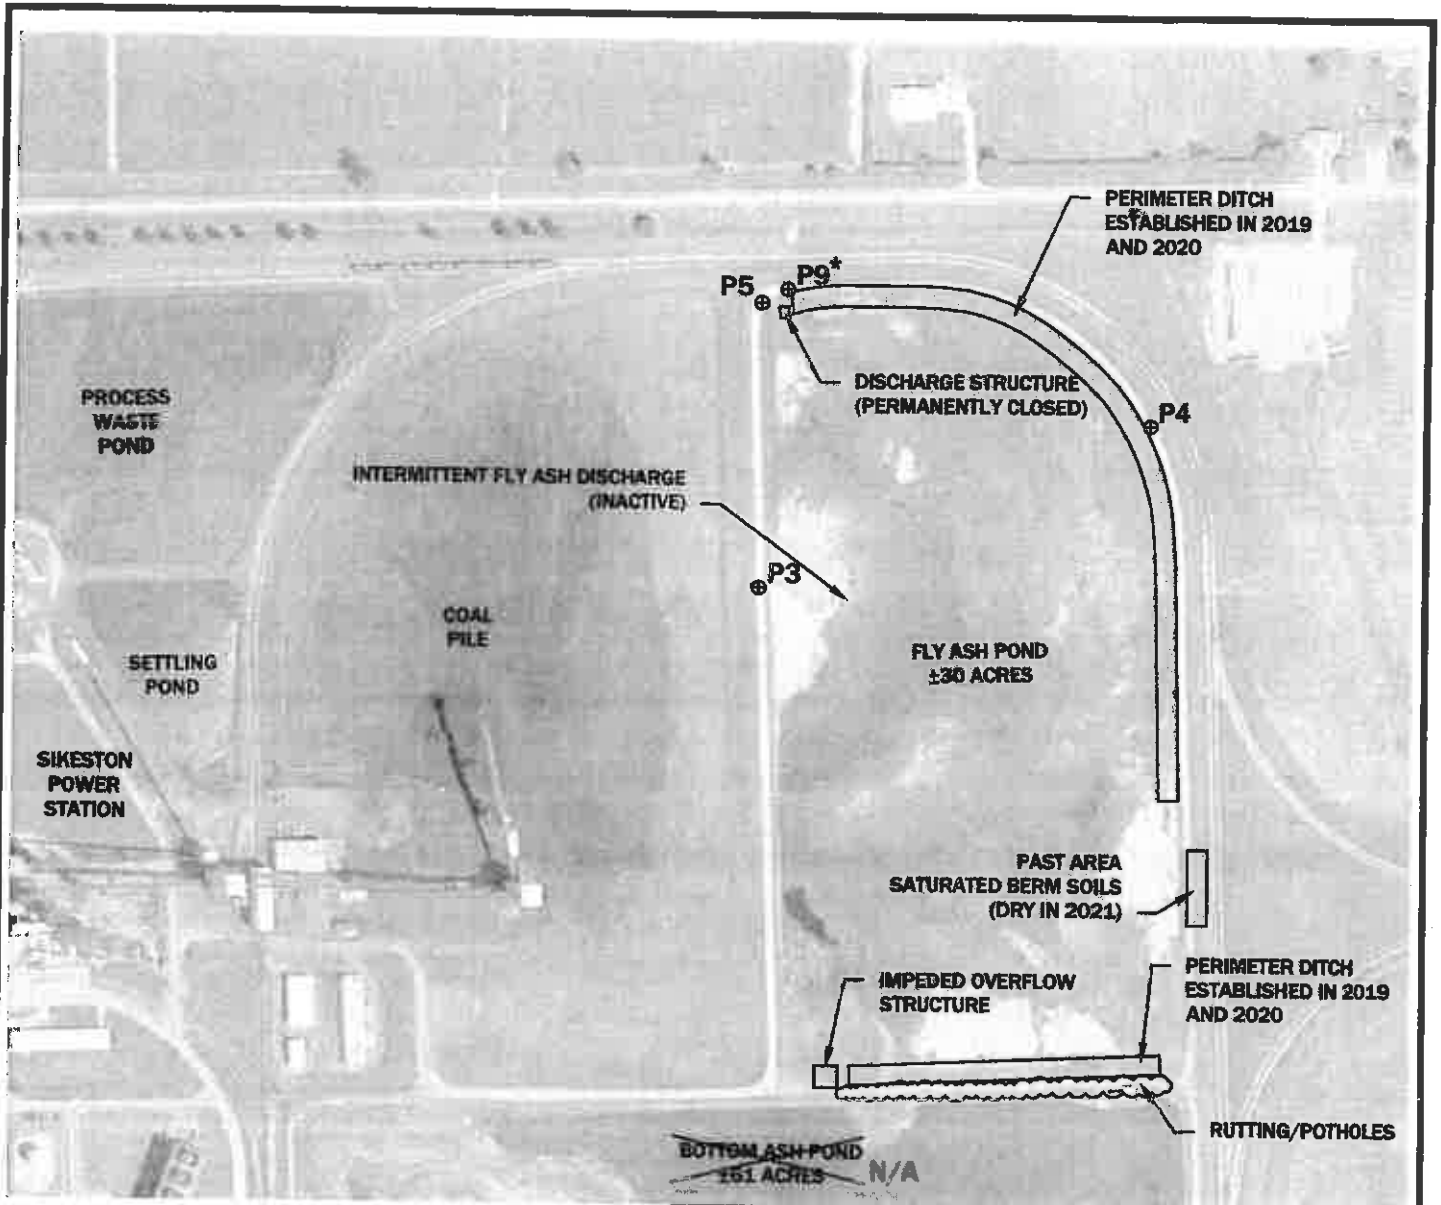
1. MINOR MAINTENANCE ITEMS INCLUDE:
  - a. EXCAVATE INTERIOR STORMWATER CHANNEL 2 FEET DEEP ALONG POND PERIMETER (WHERE REQUIRED)
  - b. REPAIR FLUSH MOUNT COVER AND LOCK FOR PIEZOMETER 9.\*
2. REQUIRING FURTHER OBSERVATION INCLUDE:
  - a. SATURATED BERM SOIL ALONG SOUTHEAST BERM.
  - b. MONITOR ACCUMULATION OF PONDED RAINFALL DURING WEEKLY INSPECTIONS.
  - c. MONITOR FOR BURROWING ANIMALS AND REMOVE THEM AS NEEDED.
3. ITEMS IDENTIFIED DURING THE ANNUAL INSPECTION WHICH DO NOT REQUIRE MAINTENANCE:
  - a. THE IMPEDED OVERFLOW STRUCTURE BETWEEN THE BOTTOM ASH POND AND THE FLY ASH POND.
  - b. PERMANENTLY CLOSED DISCHARGE STRUCTURE.
