Checklist for P.E. Annual Inspection for CCR Surface Impoundments, § 257.83(b)

Sikeston BMU Sikeston Power Station Fly Ash Surface Impoundment

Annual Inspection

**2017 INITIAL ANNUAL P.E. INSPECTION
FLY ASH POND
SIKESTON POWER STATION**

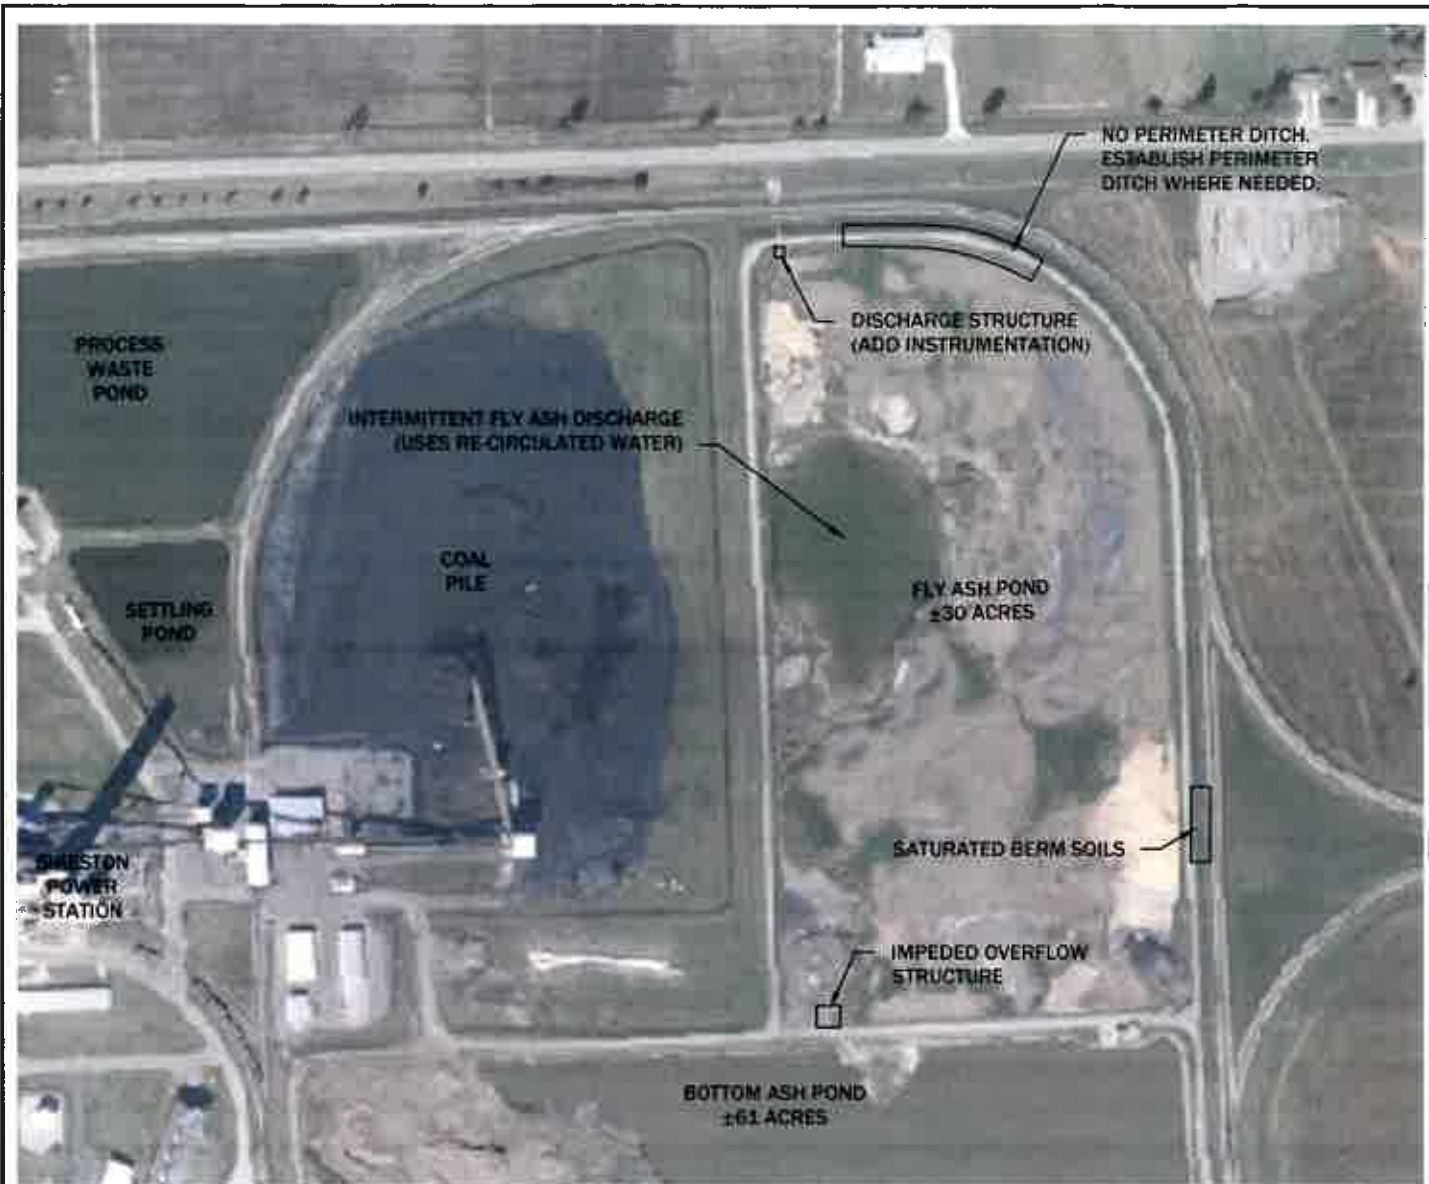
FIGURE 1

Requirements	Signs of actual or potential structural weakness (257.83(b)(v))	Disruptions or potential disruption to the operation and safety of the unit (257.83(b)(vi))
CCR Unit and appurtenant structures 257.83(b)(ii)	Potential seepage along southeastern embankment of the Fly Ash Pond.	None Observed. Continue to monitor.

Earth Embankment		
Item	Condition Code	Comments
Vertical & Horizontal Alignment of Crest	GC	No visible evidence of deformation of embankment.
Seepage/Wetness / Ponding Areas	OB (Seepage)	An area along the exterior of the southeastern berm of the Fly Ash Pond was identified as an area of potential seepage from the Fly Ash Pond. The wet area was identified as an area of potential seepage from the Fly Ash Pond based on the presence of a small number of cattails a few feet up the slope from the perimeter stormwater ditch inside of the railroad loop. No visual signs of erosion of the outer berm soils were observed. The area was able to be maintained (the vegetation had been recently cut). It is recommended that this area continue to be visually monitored and that further investigation of the wet area be considered.
Erosion/Rutting	NE	No evidence.
Fencing	GC	Fencing is only adjacent to the Fly Ash Surface Impoundment on the north perimeter.

1. The location of observations on attached plan sheet (Figure 1).

Some areas around the inside top of the containment berm lack a 2 foot deep drainage channel to direct stormwater away from the edge of the Fly Ash Pond. It is recommended that a minimum 2 foot deep drainage channel be excavated around the perimeter of the Fly Ash Pond, where needed, to prevent the uncontrolled discharge of stormwater over the top of the berm during or following heavy rainfall events.

1. MINOR MAINTENANCE ITEMS INCLUDE:
 - a. CLEAN SEDIMENT AND VEGETATION FROM DISCHARGE STRUCTURE.
 - b. EXCAVATE STORMWATER CHANNEL 2 FEET DEEP ALONG POND PERIMETER (WHERE REQUIRED).
2. REQUIRING FURTHER OBSERVATION INCLUDE:
 - a. SATURATED BERM SOIL ALONG SOUTHEAST BERM.
3. ITEMS IDENTIFIED DURING THE INITIAL INSPECTION WHICH DO NOT REQUIRE MAINTENANCE INCLUDE:
 - a. THE IMPEDED OVERFLOW STRUCTURE BETWEEN THE BOTTOM ASH POND AND THE INACTIVE FLY ASH POND.
