2021 Checklist for P.E. Annual Inspection for CCR Surface Impoundments, §

257.83(b) Sikeston BMU Sikeston Power Station Bottom Ash Surface

Impoundment Annual Inspection

SIKESTON POWER STATION – BOTTOM ASH POND
2021 ANNUAL INSPECTION CHECK SHEET

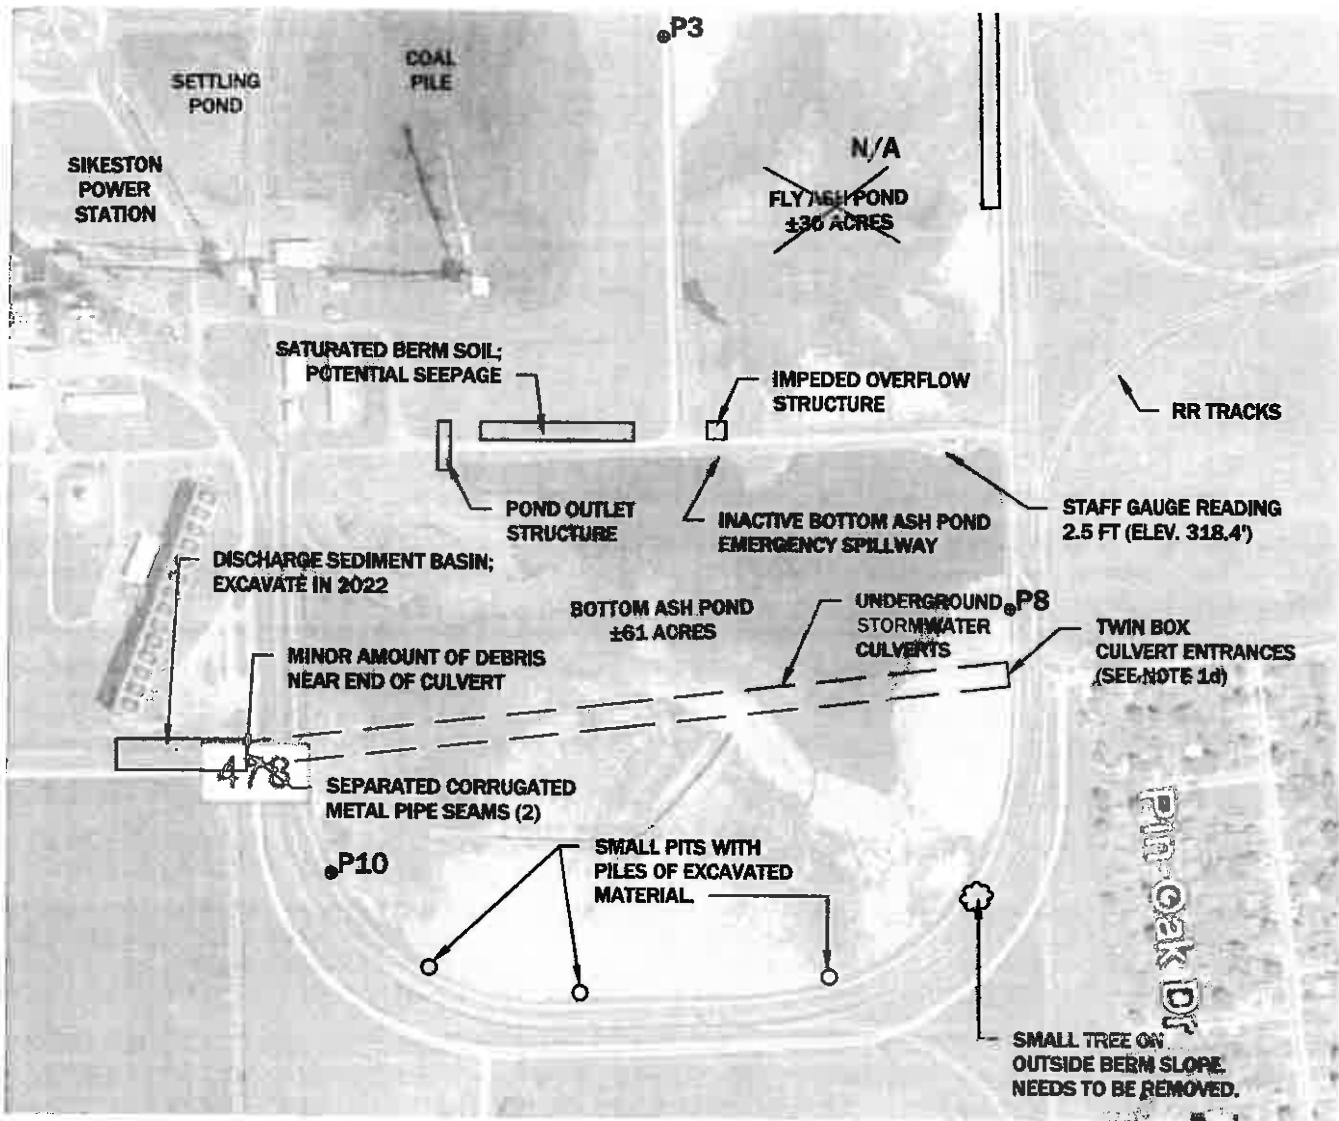
**FIGURE 1
2021 ANNUAL P.E. INSPECTION
BOTTOM ASH POND**

1. ITEMS REQUIRING FURTHER OBSERVATION, INVESTIGATION OR CORRECTIVE ACTION INCLUDE:
 - a. SATURATED BERM SOIL ALONG NORTHERN BERM, WEST OF THE FLY ASH POND. (SAME AS 2020)
 - b. SEPARATED CORRUGATED METAL PIPE SEAMS AT THE DISCHARGE OF THE SOUTHERN STORMWATER CULVERT PASSING BENEATH THE BOTTOM ASH POND. (SAME AS 2020. REPORTED NOT REPAIRED)
 - c. GRASS LINED CHANNEL AT THE DISCHARGE OF THE STORMWATER AT THE OUTLET OF THE STORMWATER CULVERTS PASSING BENEATH THE BOTTOM ASH POND FROM EAST TO WEST HAS BEEN CLEARED OF BRUSH A SEDIMENT BASIN. BASIN FILLED WITH SEDIMENT AND DEBRIS. RE-EXCAVATE MOSTLY IN 2022.
 - d. TWIN BOX CULVERT VIDEO INSPECTION PERFORMED TO VERIFY STRUCTURAL STABILITY.
2. ITEMS IDENTIFIED DURING THE ANNUAL INSPECTION WHICH DO NOT REQUIRE MAINTENANCE:
 - a. THE IMPEDED OVERFLOW STRUCTURE BETWEEN THE BOTTOM ASH POND AND THE FLY ASH POND.
