2024 Checklist for P.E. Annual Inspection for CCR Surface Impoundments, §257.83(b) Sikeston BMU Sikeston Power Station Bottom Ash Surface Impoundment Annual Inspection

SIKESTON POWER STATION – BOTTOM ASH POND
 2024 ANNUAL INSPECTION CHECK SHEET
NOTE – BAP IS INACTIVE SINCE JUNE 5, 2023

**FIGURE 1
BOTTOM ASH POND
2024 ANNUAL INSPECTION**

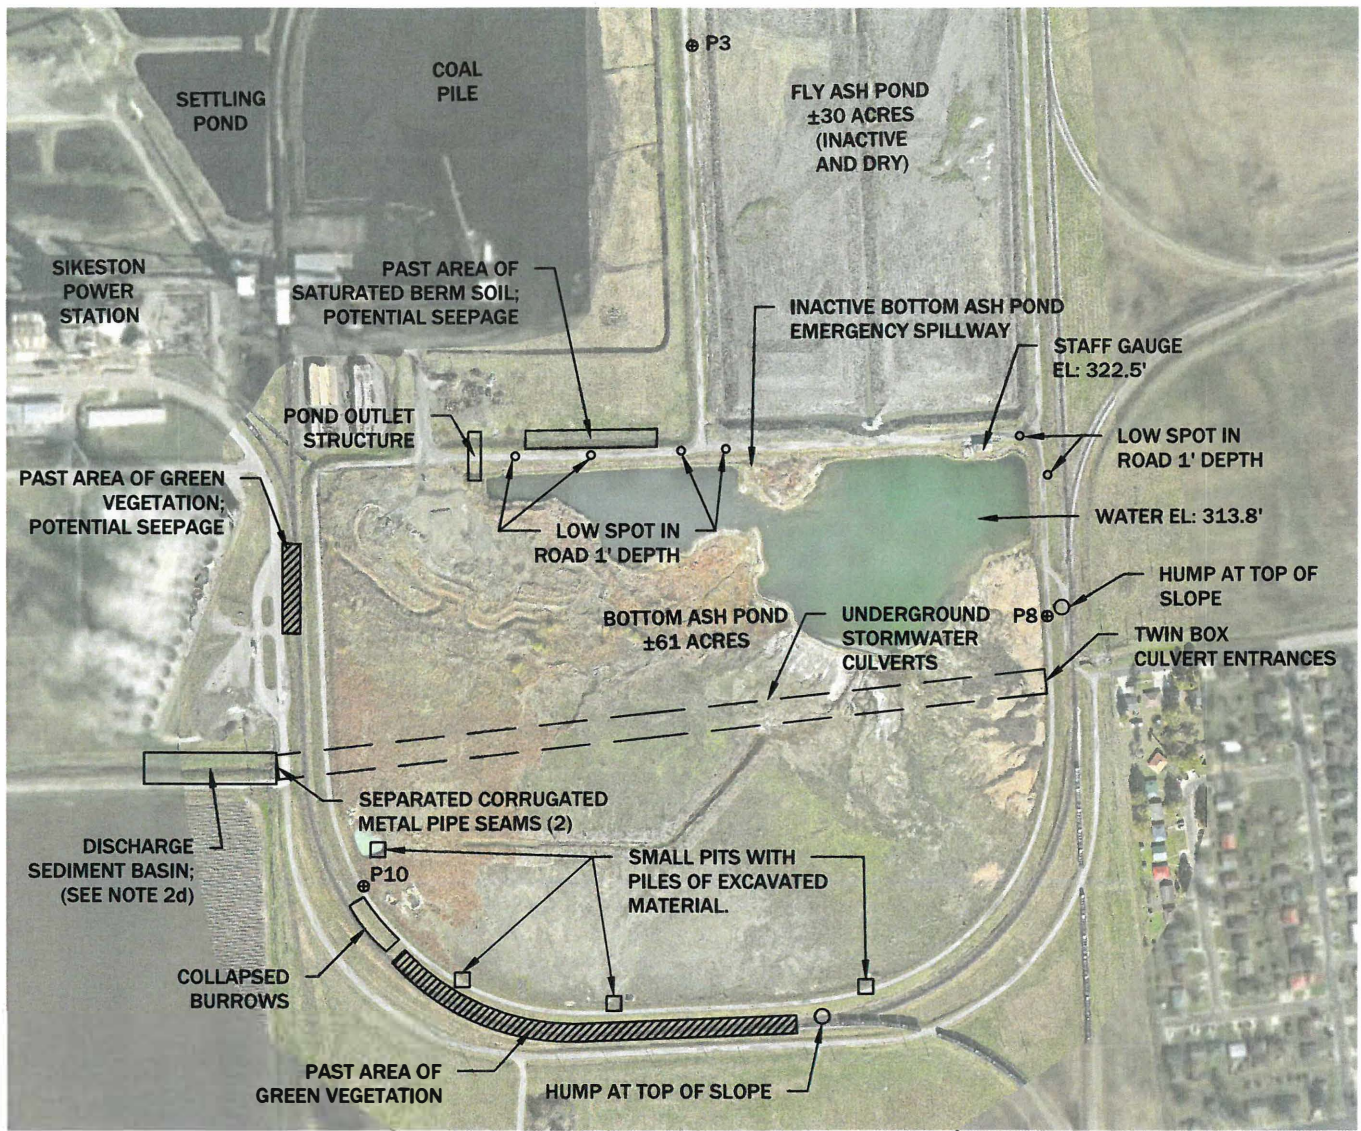
1. IMMEDIATE MAINTENANCE ITEMS INCLUDE:
 - a. COLLAPSED BURROWS ALONG THE SOUTHEAST CORNER OF BERM.
2. MINOR MAINTENANCE ITEMS INCLUDE:
 - a. APPROXIMATELY FIVE LOW SPOTS IN THE GRAVEL ROAD ON THE NORTH PERIMETER BERM OF THE BOTTOM ASH POND.

3. ITEMS REQUIRING FURTHER OBSERVATION INCLUDE:
 - a. PAST AREA OF SATURATED BERM SOIL ALONG NORTHERN BERM, WEST OF THE FLY ASH POND. (CONDITIONS ARE UNCHANGED SINCE 2016)

- b. PAST AREA OF GREEN VEGETATION ON WESTERN AND SOUTHWESTERN BERM SLOPES INDICATE POSSIBLE SEEPAGE. CONTINUED OBSERVATION AND MONITORING RECOMMENDED.

- c. SEPARATED CORRUGATED METAL PIPE SEAMS AT THE DISCHARGE END OF THE SOUTHERN STORMWATER CULVERT PASSING BENEATH THE BOTTOM ASH POND. (CONDITIONS ARE UNCHANGED SINCE 2016)

- d. GRASS LINED CHANNEL AT THE OUTLET OF THE STORMWATER CULVERTS PASSING BENEATH THE BOTTOM ASH POND FROM EAST TO WEST REMAINS CLEAR OF BRUSH. THE SEDIMENT BASIN IS PARTLY FILLED WITH SEDIMENT AND DEBRIS. RE-EXCAVATION OF THE SEDIMENT BASIN IS RECOMMENDED IN 2024.

- a. THE HISTORICALLY IMPEDED OVERFLOW STRUCTURE BETWEEN THE BOTTOM ASH POND AND THE FLY ASH POND.
