2025 Checklist for P.E. Annual Inspection for CCR Surface Impoundments, §257.83(b) Sikeston BMU

### Sikeston Power Station Bottom Ash Surface Impoundment Annual Inspection

**FIGURE 1**  
**BOTTOM ASH POND**  
**2025 ANNUAL INSPECTION**

**SIKESTON POWER STATION**

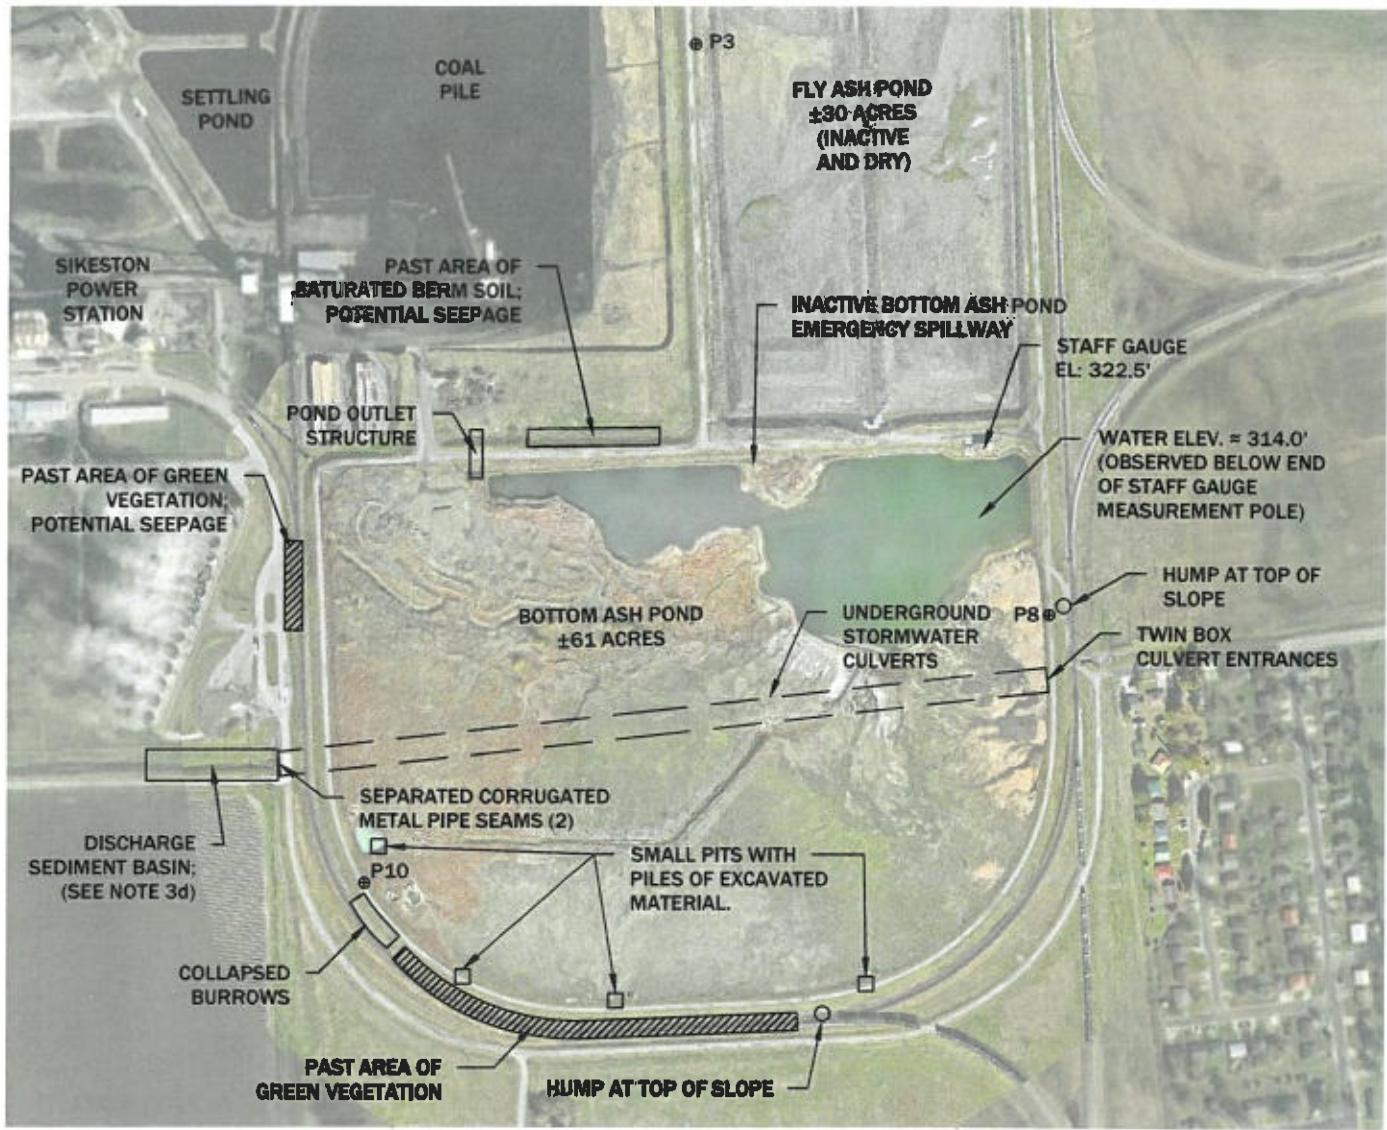
1. IMMEDIATE MAINTENANCE ITEMS INCLUDE:
  - a. COLLAPSED BURROWS ALONG THE SOUTHEAST CORNER OF BERM.
2. MINOR MAINTENANCE ITEMS INCLUDE:
  - a. APPROXIMATELY FIVE LOW SPOTS IN THE GRAVEL ROAD ON THE NORTH PERIMETER BERM OF THE BOTTOM ASH POND.

3. ITEMS REQUIRING FURTHER OBSERVATION INCLUDE:
  - a. PAST AREA OF SATURATED BERM SOIL ALONG NORTHERN BERM, WEST OF THE FLY ASH POND. (CONDITIONS ARE UNCHANGED SINCE 2016)

- b. PAST AREA OF GREEN VEGETATION ON WESTERN AND SOUTHWESTERN BERM SLOPES INDICATE POSSIBLE SEEPAGE. CONTINUED OBSERVATION AND MONITORING RECOMMENDED.

- c. SEPARATED CORRUGATED METAL PIPE SEAMS AT THE DISCHARGE END OF THE SOUTHERN STORMWATER CULVERT PASSING BEHIND THE BOTTOM ASH POND. (CONDITIONS ARE UNCHANGED SINCE 2016)

- d. GRASS-LINED CHANNEL AT THE OUTLET OF THE STORMWATER CULVERT PASSING BEHIND THE BOTTOM ASH POND FROM EAST TO WEST REMAINS CLEAR OF BRUSH. THE SEDIMENT BASIN IS PARTLY FILLED WITH SEDIMENT AND DEBRIS. RE-EXCAVATION OF THE SEDIMENT BASIN IS RECOMMENDED IN 2026.

- a. THE HISTORICALLY IMPEDED OVERFLOW STRUCTURE BETWEEN THE BOTTOM ASH POND AND THE FLY ASH POND.
