2025 Checklist for P.E. Annual Inspection for CCR Surface Impoundments, § 257.83(b)

### Sikeston BMU Sikeston Power Station Fly Ash Surface Impoundment Annual Inspection

**SIKESTON POWER STATION – FLY ASH POND**  
**2025 ANNUAL INSPECTION CHECK SHEET**

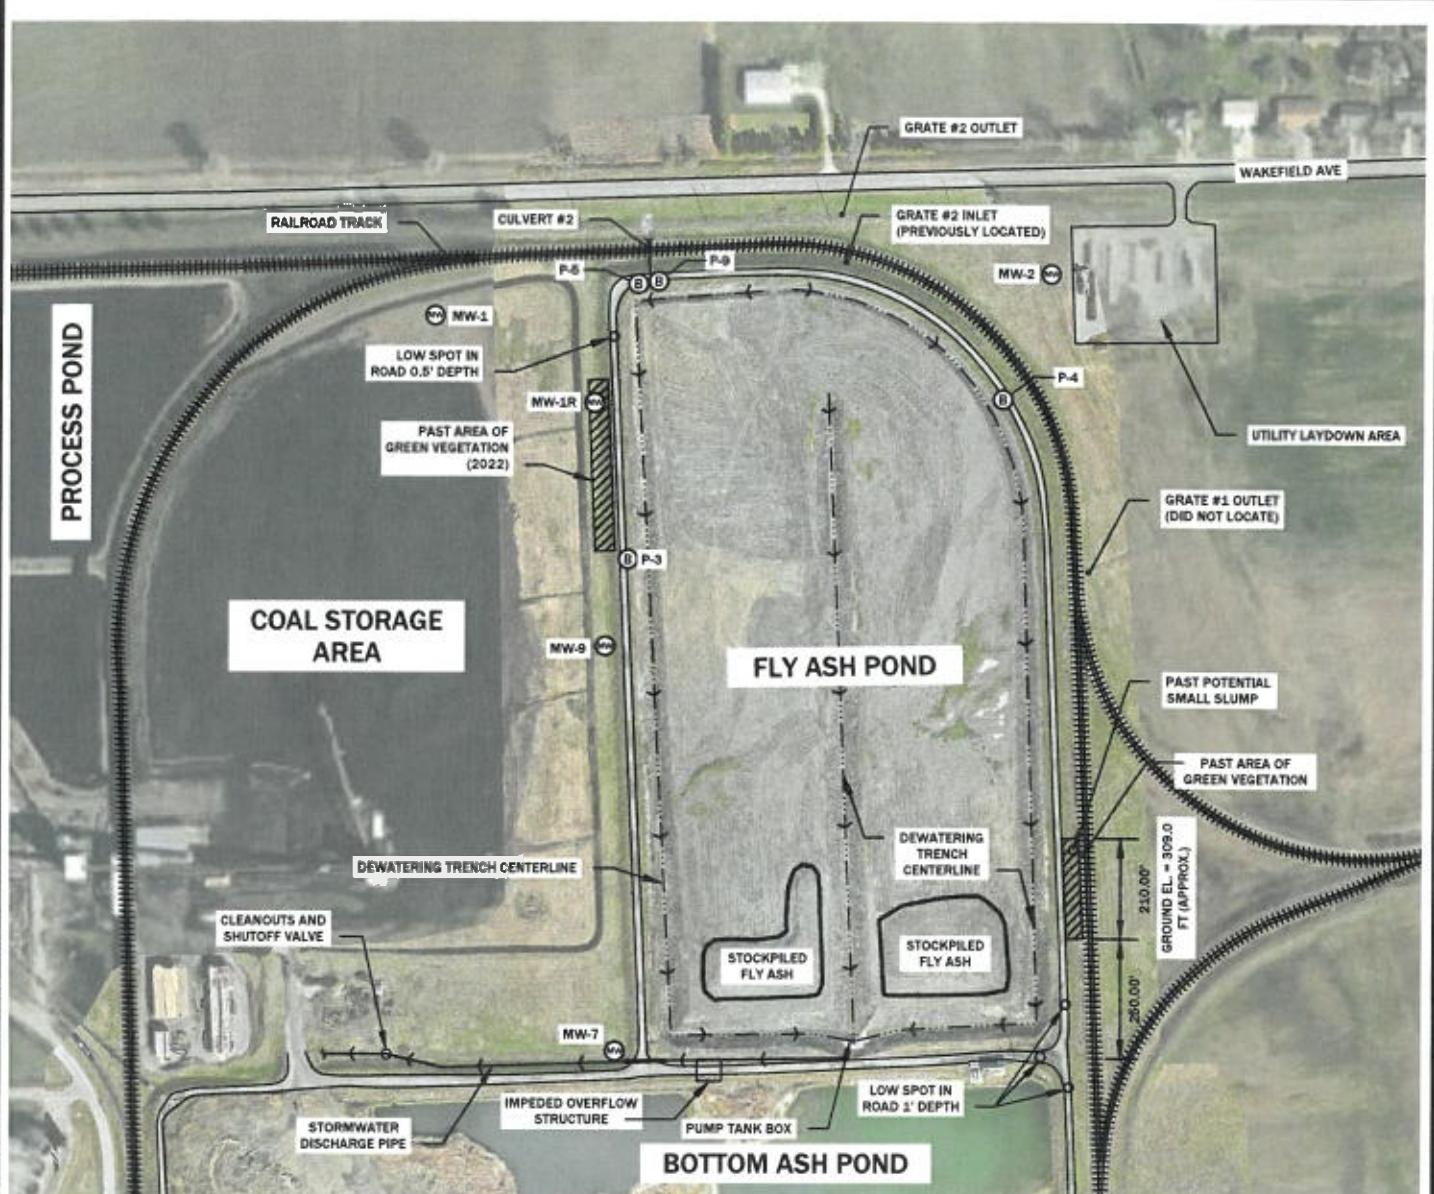
**FIGURE 1**  
**PRE CLOSURE CONDITION**  
**2025 ANNUAL INSPECTION**

1. MINOR MAINTENANCE ITEMS INCLUDE:
  - a. TWO LOW SPOTS IN THE BERM ROAD: ONE NEAR SOUTHEAST CORNER; AND ONE NEAR NORTHWEST CORNER.
2. ITEMS RECOMMENDED FOR CONTINUED OBSERVATION INCLUDE:
  - a. GREEN VEGETATION IN THE AREAS ALONG THE SOUTHEAST BERM AND NORTHWEST BERM INDICATES POSSIBLE SEEPAGE. CONTINUED OBSERVATION RECOMMENDED.
3. ITEMS IDENTIFIED DURING THE ANNUAL INSPECTION WHICH DO NOT REQUIRE MAINTENANCE:
  - a. THE IMPEDED OVERFLOW STRUCTURE BETWEEN THE BOTTOM ASH POND AND THE FLY ASH POND.
  - b. PERMANENTLY CLOSED DISCHARGE STRUCTURE.
4. PIEZOMETER LOCATIONS APPROXIMATED WITH HANDHELD GPS.
5. GRATE #1 INLET NOT IDENTIFIED.
6. IN 2024, THE PONDED CCR WAS GRADED TO PROMOTE CCR DEWATERING AND IMPROVE STORMWATER COLLECTION AND REMOVAL IN PREPARATION FOR CLOSURE.
7. AERIAL IMAGERY PROVIDED BY HAMPTON LENZINI AND RENWICK INC. (HLR), COLLECTED NOVEMBER 11, 2024.

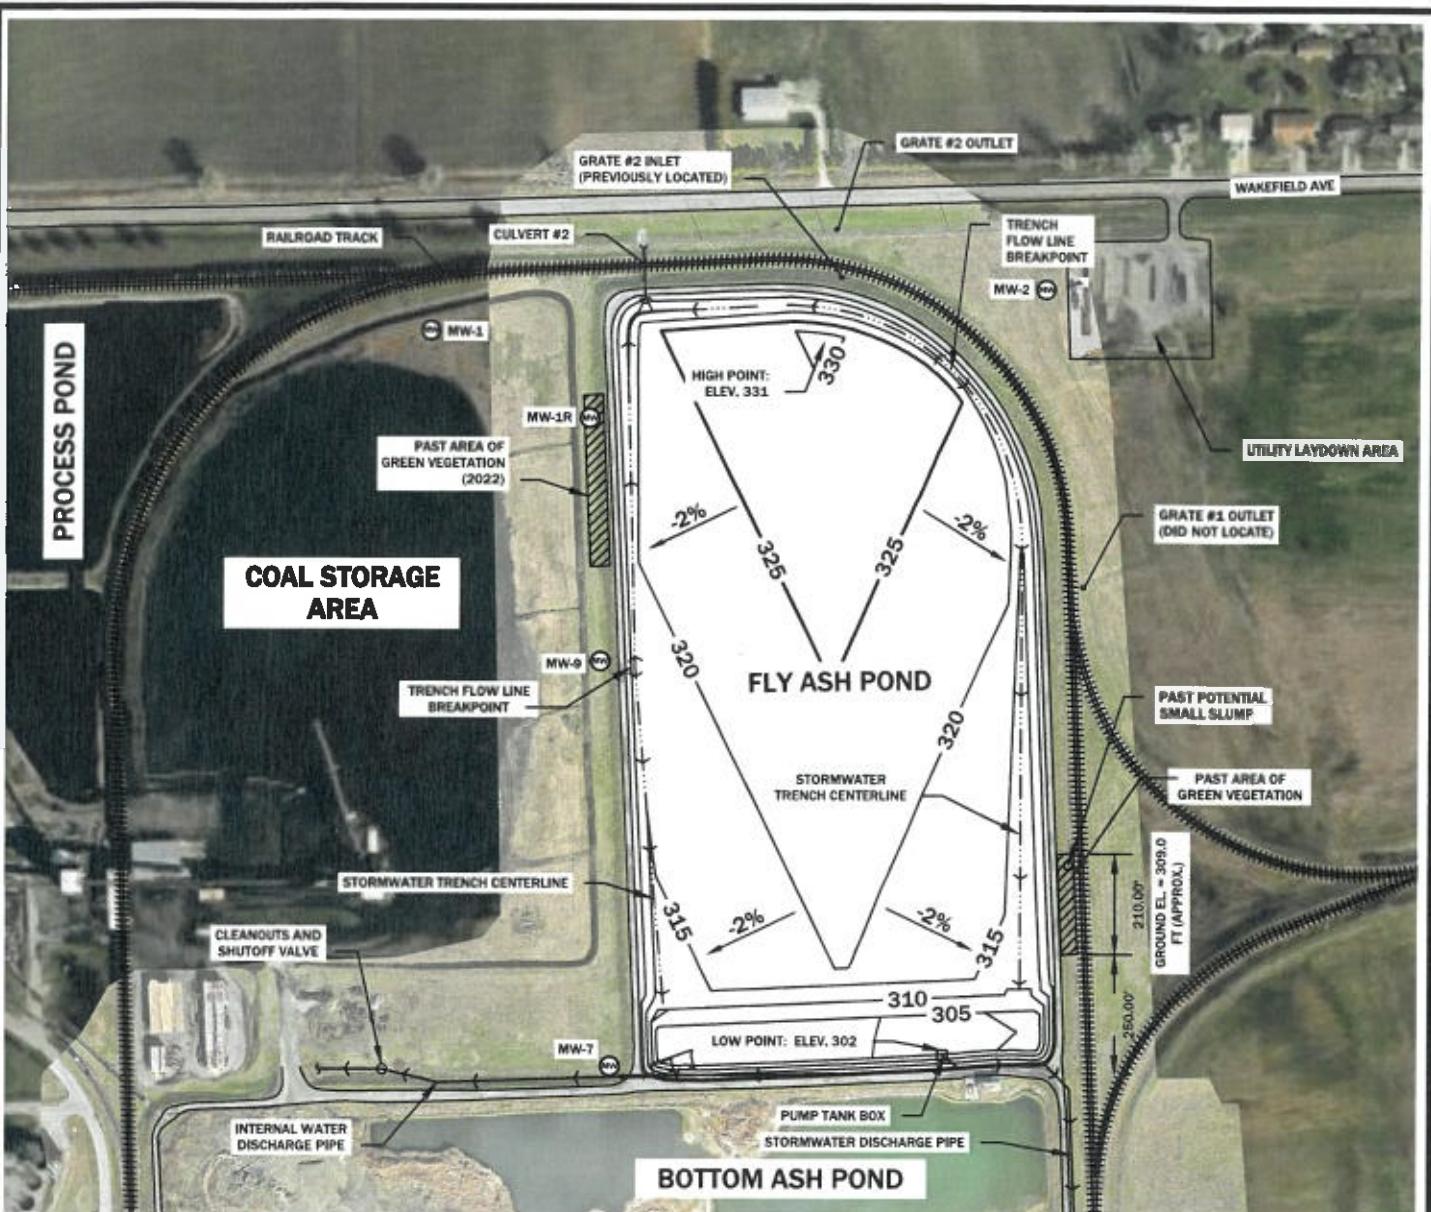
**FIGURE 2  
CLOSED CONDITION  
2025 ANNUAL INSPECTION**

1. ITEMS RECOMMENDED FOR CONTINUED OBSERVATION INCLUDE:
  - a. GREEN VEGETATION IN THE AREAS ALONG THE SOUTHEAST BERM AND NORTHWEST BERM INDICATES POSSIBLE SEEPAGE. CONTINUED OBSERVATION RECOMMENDED.

2. ITEMS IDENTIFIED DURING THE ANNUAL INSPECTION WHICH DO NOT REQUIRE MAINTENANCE:
  - a. THE IMPEDED OVERFLOW STRUCTURE BETWEEN THE BOTTOM ASH POND AND THE FLY ASH POND HAS BEEN DEMOLISHED.

3. GRATE #1 INLET NOT IDENTIFIED.
4. IN 2024, THE PONDED CCR WAS GRADED TO PROMOTE CCR DEWATERING AND IMPROVE STORMWATER COLLECTION AND REMOVAL IN PREPARATION FOR CLOSURE.
