OPERATING RECORD DOCUMENT

**Sikeston Board of Municipal Utilities
Sikeston Power Station
Fly Ash Pond
Periodic Structural Stability Assessment**

Updated February 2024

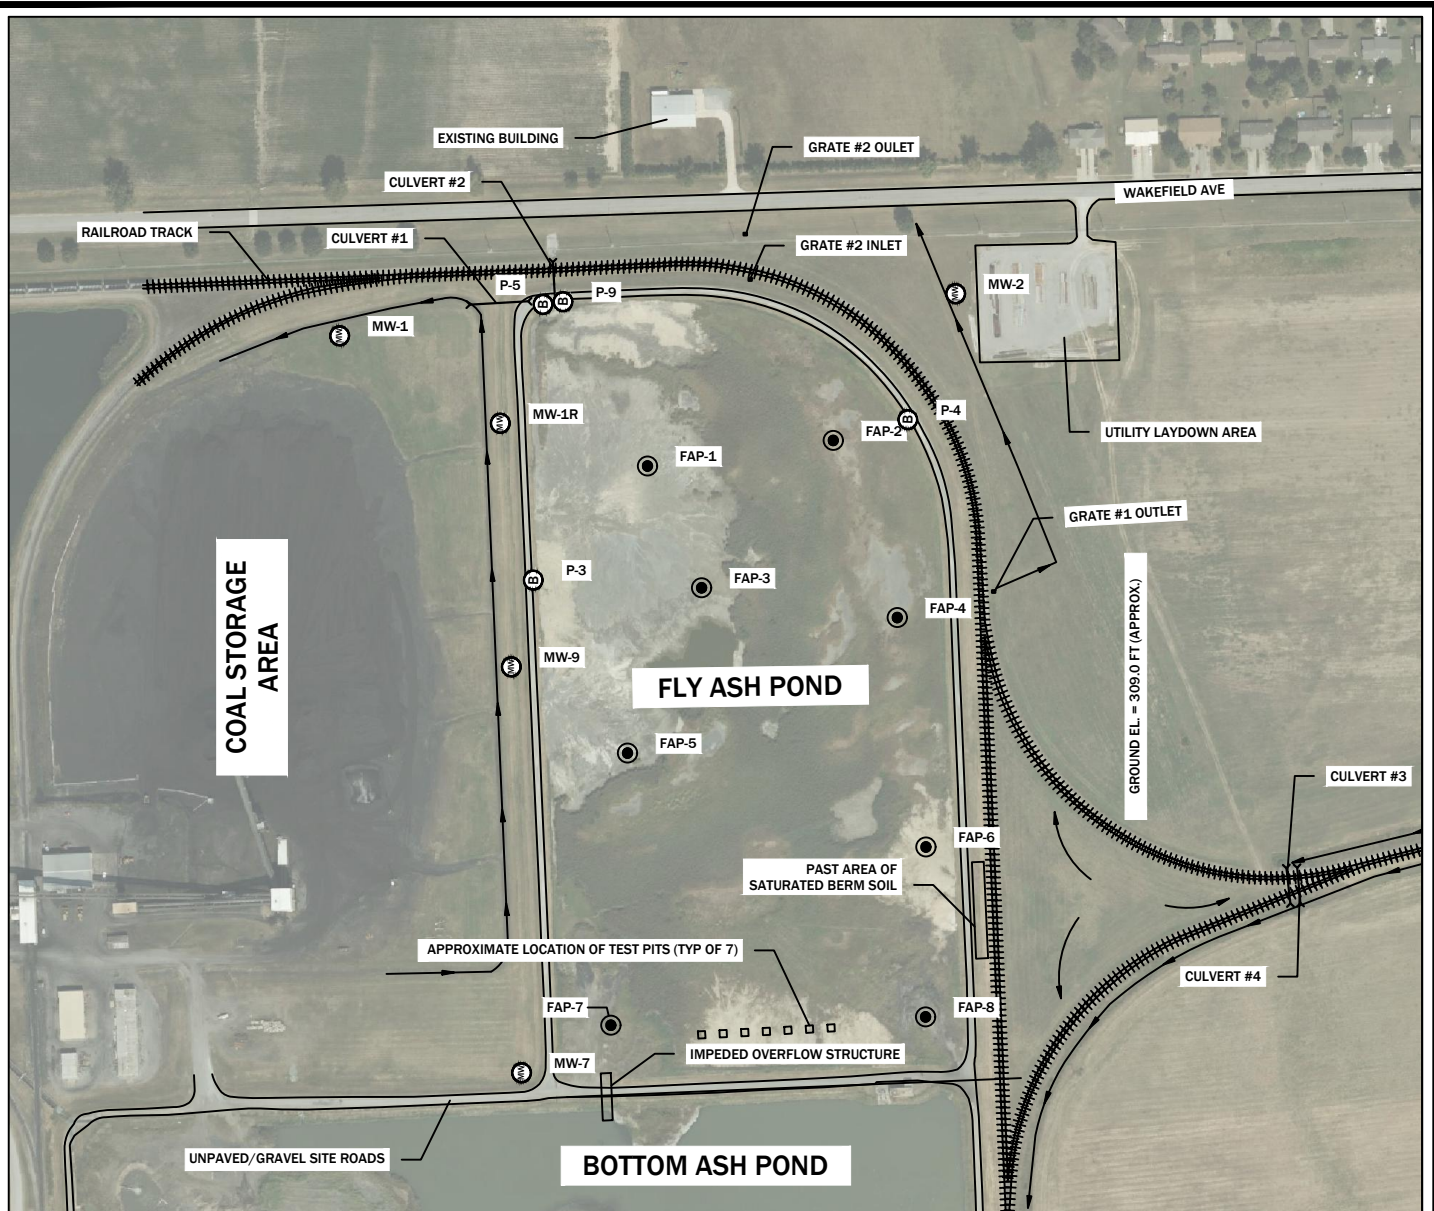
FIGURE 2 - FLY ASH POND IDENTIFIED DEFICIENCIES

The 2023 visual inspection of the berms of the Fly Ash Pond identified a similar small area of saturated soil along the southeastern berm of the Fly Ash Pond as observed in 2018. The wet ground conditions were observed to begin approximately midway on the exterior slope of the berm (approximate elevation of 314 feet) and continued to the toe of the exterior slope of the berm. The type of grass vegetation was visually observed to change along a horizontal line on the exterior slope of the berm that generally matched the beginning of the wet conditions.

The presence of hydric plants indicate that the wet condition of the soil may be the result of seepage through the southeastern berm from the Fly Ash Pond. However, no visible flow was observed and stability analysis of critical sections of Fly Ash Pond berms by Reitz & Jens, as a sub-consultant to GER, reportedly exceed the minimum Factors of Safety required by the CCR rule.

Based on the observations and rationale described above, the wet, saturated soil condition is identified as a deficiency under the rule. Consistent with recognized and generally accepted good engineering practices, it would be recommended that SPS complete corrective measures to further evaluate the potential seepage through the southeast berm of the Ash Pond. However, since the Fly Ash Pond is inactive and is scheduled to begin closure in 2024, corrective measures are no longer considered to be necessary.

One hydraulic deficiency has been noted during past assessments of the Fly Ash Pond. The emergency spillway (a 30-inch CMP pipe) between the Bottom Ash Pond and the Fly Ash Pond has been inoperable since GER's observations began in 2016. The pipe is due to excess fly ash at the discharge of the 30-inch corrugated metal pipe impeding the flow path between the two

1. INTERNAL PIEZOMETERS INSTALLED IN 2022
2. PIEZOMETER LOCATIONS APPROXIMATED WITH HANDHELD GPS.
3. IMAGE PROVIDED BY MICROSOFT BING MAPS; APPROXIMATE IMAGE DATE 2022.
4. POTENTIAL DEFICIENCIES INCLUDE: PAST AREA OF SATURATED BERM SOIL AND IMPEDED OVERFLOW STRUCTURE (SEE REPORT FOR DETAILED DISCUSSION.)

ponds. Consistent with recognized and generally accepted good engineering practices, it has been recommended in the past that SPS complete corrective measures to either remove the accumulated CCR from the discharge end of the overflow structure, or construct an alternate overflow structure (i.e., emergency spillway) capable of adequately managing flow during and following the peak discharge from the design flood event. However, since the Fly Ash Pond has been inactive since 2021 and is scheduled to begin closure in 2024, corrective measures are no longer considered to be necessary.

- A small area of wet/saturated soil was identified along the exterior of the eastern berm of the Fly Ash Pond. The wet area was observed a few feet above the toe of the exterior slope of the berm inside of and above the stormwater swale railroad track. The small area was manifested as a patch of hydrophilic plants (e.g., cattails). Therefore, GER has identified this condition as a potential CCR rule deficiency and recommends that SPS observe this condition to assure it does not worsen over time.
