**2023 Checklist for P.E. Annual Inspection for CCR Surface Impoundments, §257.83(b) Sikeston BMU Sikeston Power Station Bottom Ash Surface Impoundment Annual Inspection**

**SIKESTON POWER STATION – BOTTOM ASH POND  
2023 ANNUAL INSPECTION CHECK SHEET  
NOTE – BAP IS INACTIVE SINCE JUNE 5, 2023**

**SIKESTON POWER STATION**  
Bottom Ash Pond  
Annual Inspection Check Sheet

**FIGURE 1  
2023 ANNUAL INSPECTION  
BOTTOM ASH POND**

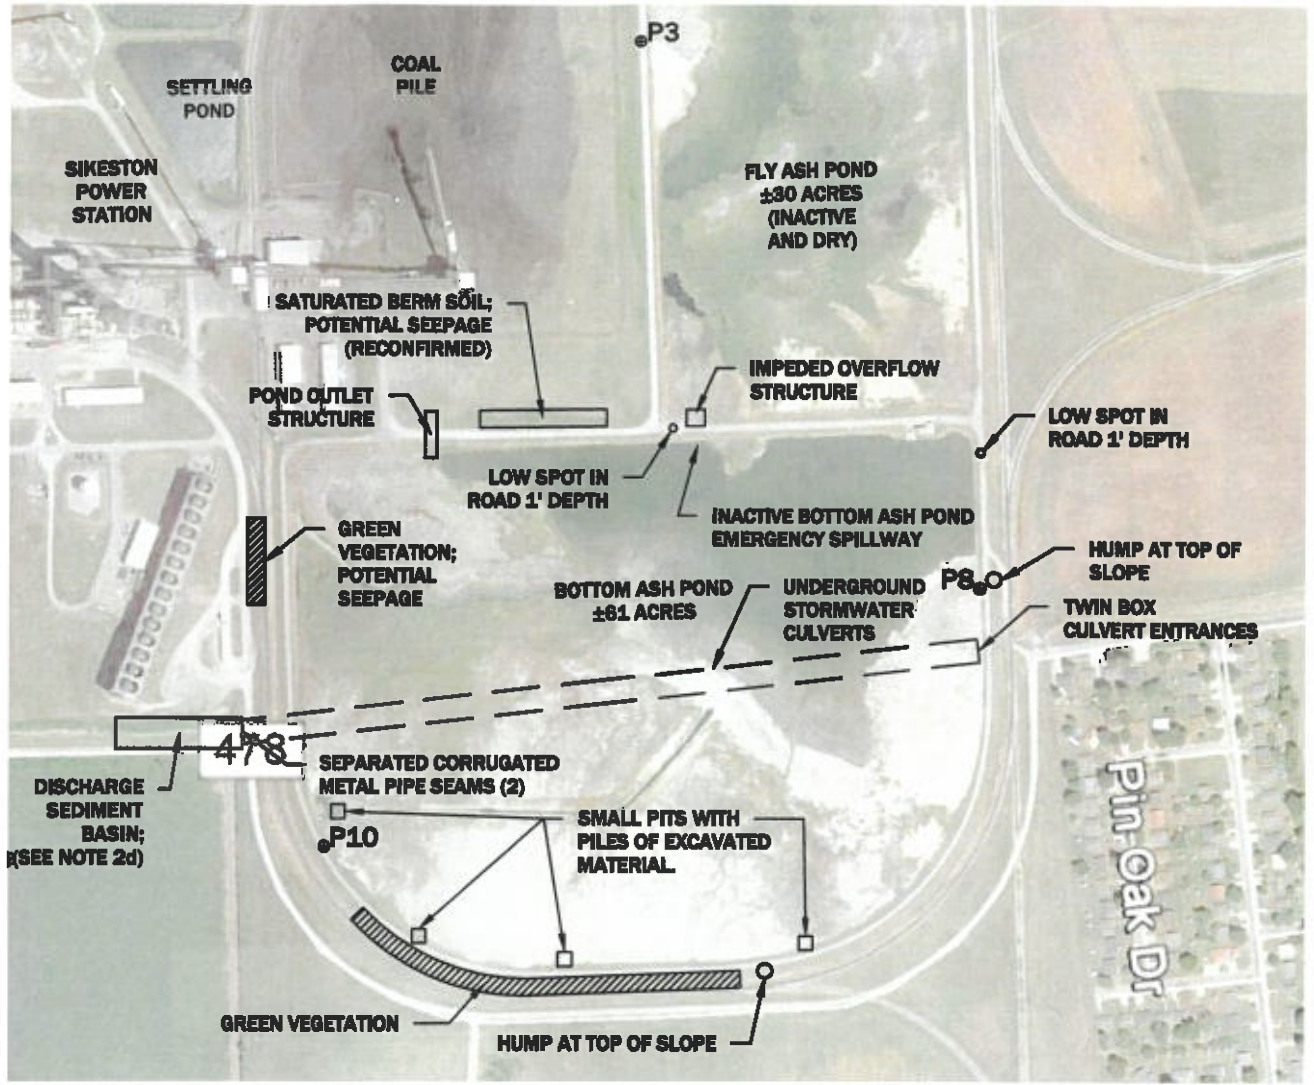
1. MINOR MAINTENANCE ITEMS INCLUDE:
  - a. ONE LOW SPOT IN THE NORTH NEAR THE SOUTHWEST CORNER BERM ROAD EAST OF THE FLY ASH POND AND ONE LOW SPOT NEAR THE NORTHEAST CORNER OF THE BERM ROAD.

2. ITEMS REQUIRING FURTHER OBSERVATION INCLUDE:
  - a. SATURATED BERM SOIL ALONG NORTHERN BERM, WEST OF THE FLY ASH POND. (CONDITIONS ARE UNCHANGED SINCE 2016)

- b. GREEN VEGETATION ON WESTERN AND SOUTHWESTERN BERM SLOPES INDICATE POSSIBLE SEEPAGE. CONTINUED OBSERVATION AND MONITORING RECOMMENDED.
  - c. SEPARATED CORRUGATED METAL PIPE SEAMS AT THE DISCHARGE END OF THE SOUTHERN STORMWATER CULVERT PASSING BENEATH THE BOTTOM ASH POND. (CONDITIONS ARE UNCHANGED SINCE 2016)

- d. GRASS LINED CHANNEL AT THE OUTLET OF THE STORMWATER CULVERTS PASSING BENEATH THE BOTTOM ASH POND FROM EAST TO WEST REMAINS CLEAR OF BRUSH. THE SEDIMENT BASIN IS MOSTLY FILLED WITH SEDIMENT AND DEBRIS. RE-EXCAVATION OF THE SEDIMENT BASIN IS RECOMMENDED IN 2024.

- e. TWIN BOX CULVERT VIDEO INSPECTION WAS COMPLETED IN 2021 TO VERIFY STRUCTURAL STABILITY.
3. ITEMS IDENTIFIED DURING THE ANNUAL INSPECTION WHICH DO NOT REQUIRE MAINTENANCE:

- a. THE HISTORICALLY IMPEDED OVERFLOW STRUCTURE BETWEEN THE BOTTOM ASH POND AND THE FLY ASH POND.
